HOME INSPECTION

Inspection Date
27/06/24

Address
**414, Malviya
Nagar, New Delhi**

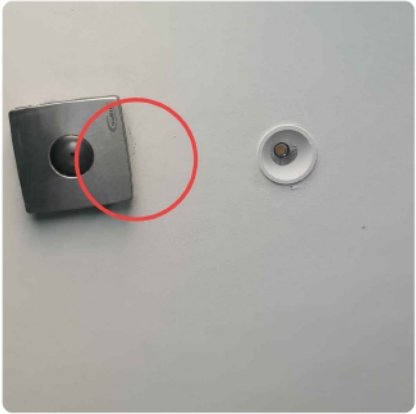
8.5.1. Toilet 2 | Major

No.	Issue	Picture
1	Crack observed on ceiling surface

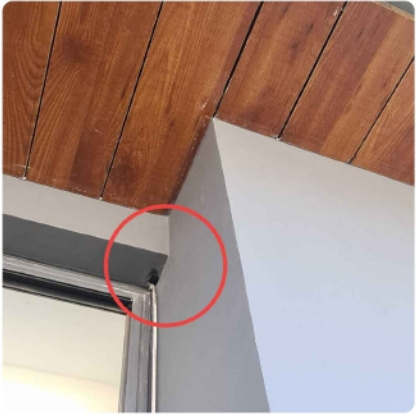
8.8.1. Living Room Balcony 1 | Major

No.	Issue	Picture
1	Damage Observed on ceiling surface

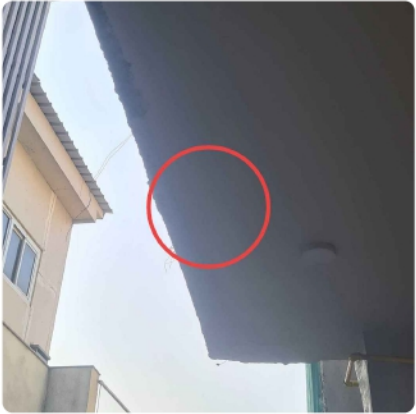
8.10.1. Utility Balcony | Major

No.	Issue	Picture
1	Undulations observed on ceiling surface

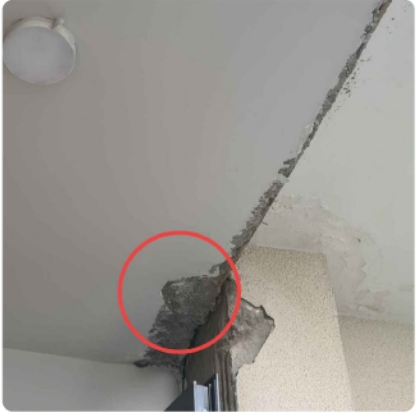
2	Damage Observed on ceiling surface

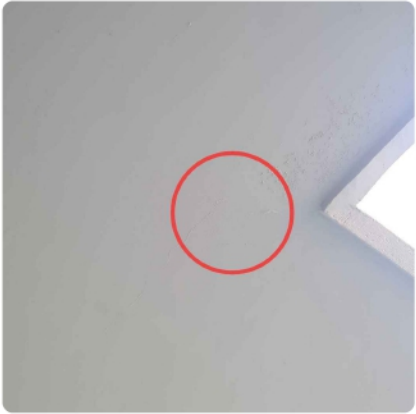
8.11.1. Bedroom 1 Balcony | Major

No.	Issue	Picture
1	Crack observed on ceiling surface

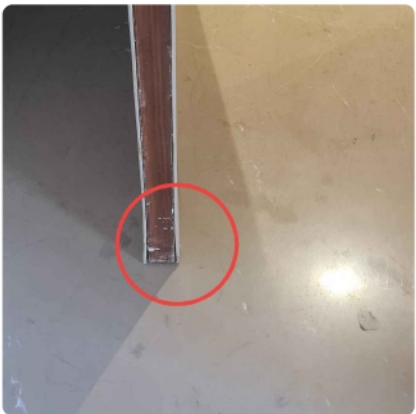
A photograph of a white door with a silver handle and lock. The door is slightly ajar, showing the hinge area.
3	Damage Observed on door shutter

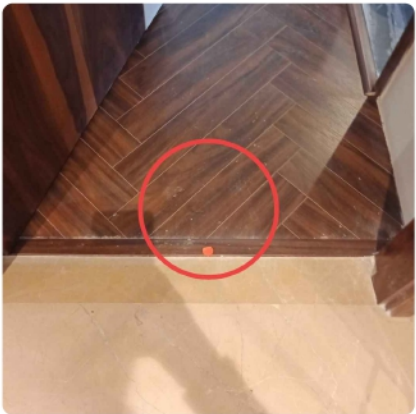
A photograph showing the bottom edge of a dark brown door frame where it meets a light-colored tiled floor. A red circle highlights a vertical crack in the frame.
4	Reducer not fixed properly

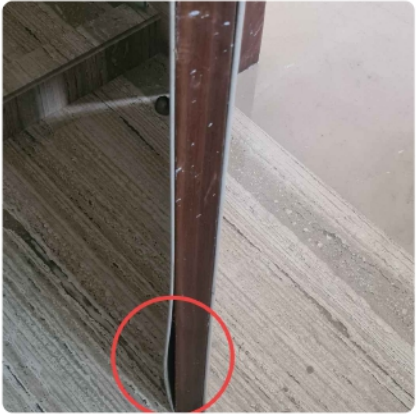
10.4.1. Toilet 1 | Major

No.	Issue	Picture
1	Damage Observed on door shutter

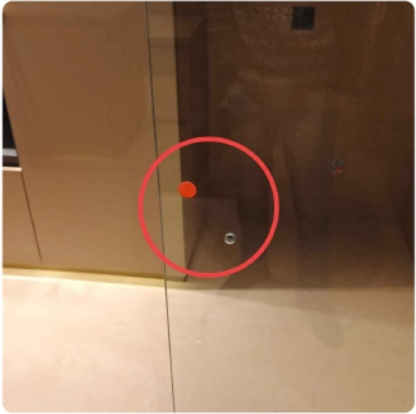
10.7.1. Kitchen | Major

No.	Issue	Picture
1	Glass door fittings are missing

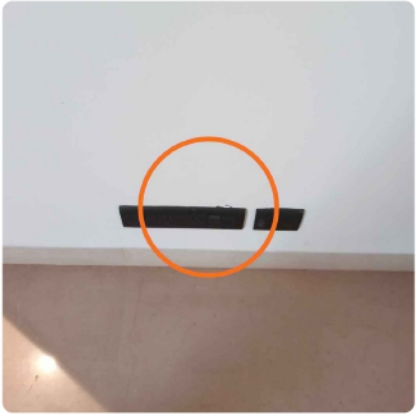
12.1.1. Bedroom 1 | Minor

No.	Issue	Picture
1	Gap observed between switch plate & wall/tile surface

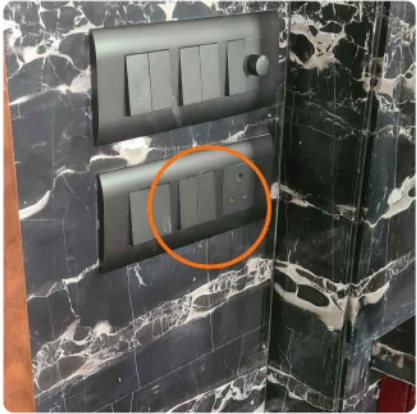
12.3.1. Toilet 2 | Cosmetic

No.	Issue	Picture
1	Stain observed on switch board

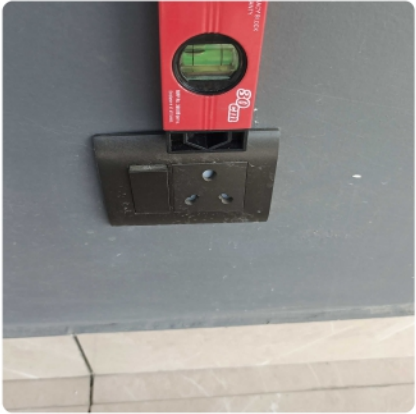
12.6.2. Living Room Balcony 2 | **Minor**

No.	Issue	Picture
1	Switch board not fixed in line or level

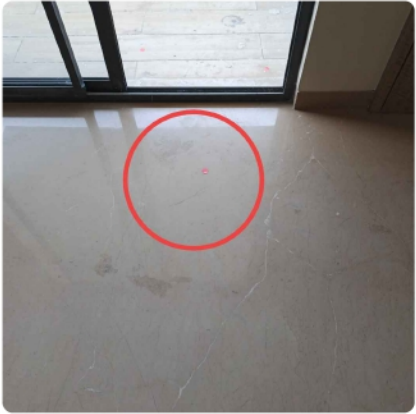
14.1.1. Bedroom 1 | Major

No.	Issue	Picture
5	Hollowness or debonding observed in floor tile

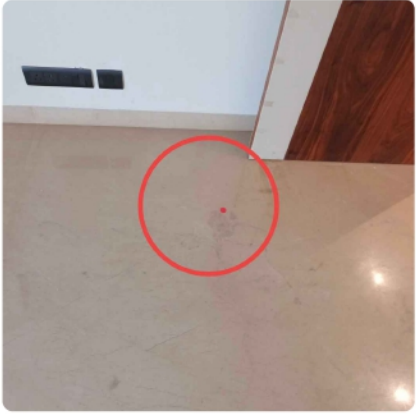
7	Hollowness or debonding observed in floor tile

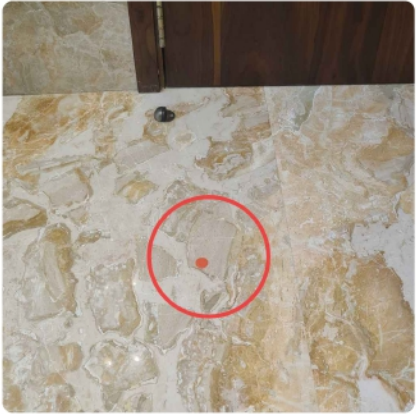
14.7.1. Toilet 4 | Major

No.	Issue	Picture
1	Hollowness or debonding observed in floor tile

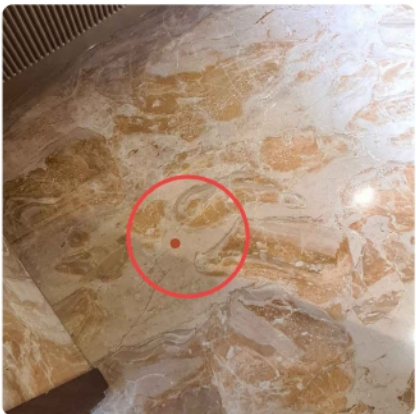
3	Hollowness or debonding observed in floor tile

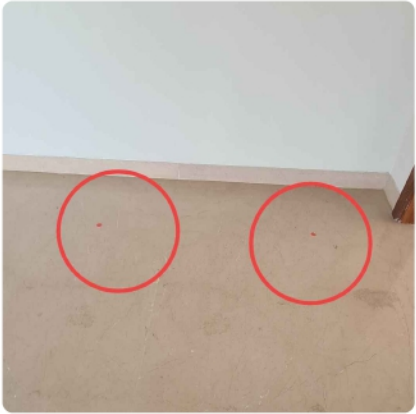
14.9.1. Living | Major

No.	Issue	Picture
9	Hollowness or debonding observed in floor tile

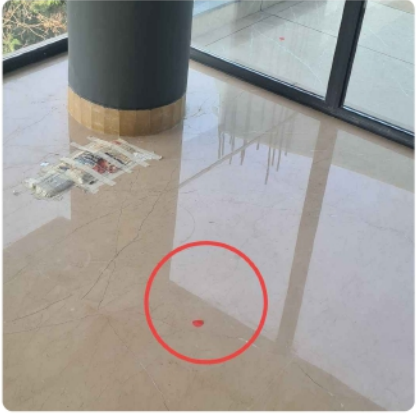
11	Hollowness or debonding observed in floor tile

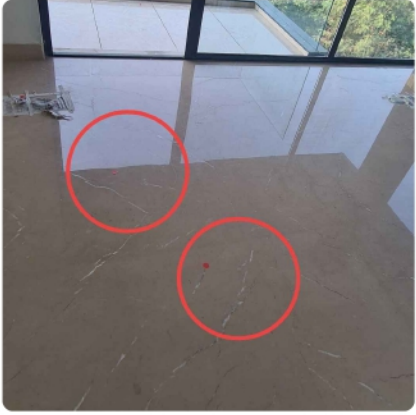
12	Hollowness or debonding observed in floor tile

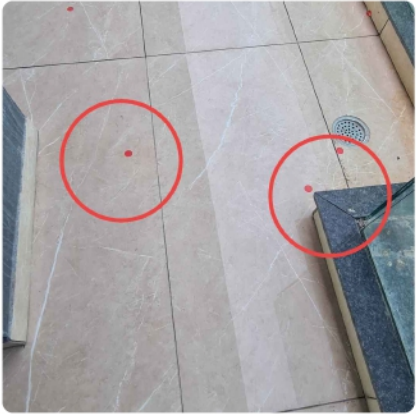
14.10.1. Living Room Balcony 1 | Major

No.	Issue	Picture
13	Hollowness or debonding observed in floor tile

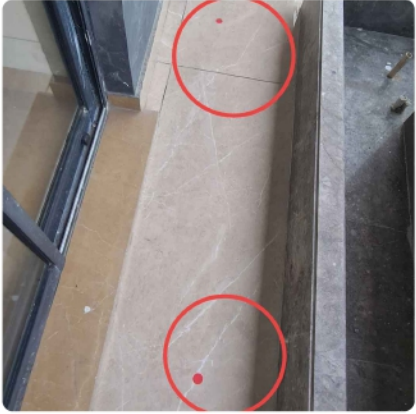
15	Hollowness or debonding observed in floor tile

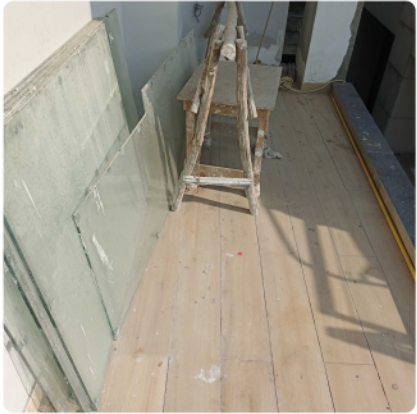
14.11.2. Living Room Balcony 2 | Cosmetic

No.	Issue	Picture
1	Deep cleaning needs to be done.

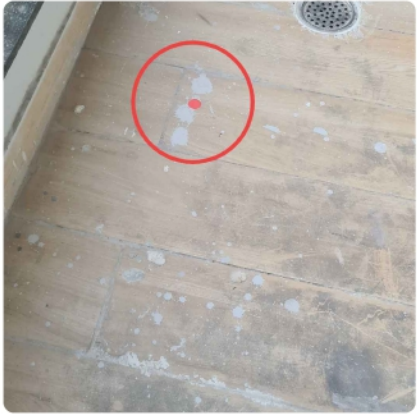
14.13.1. Bedroom 1 Balcony | Major

No.	Issue	Picture
1	Hollowness or debonding observed in floor tile

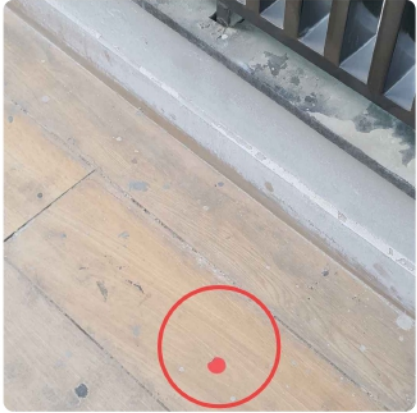
2	Hollowness or debonding observed in floor tile

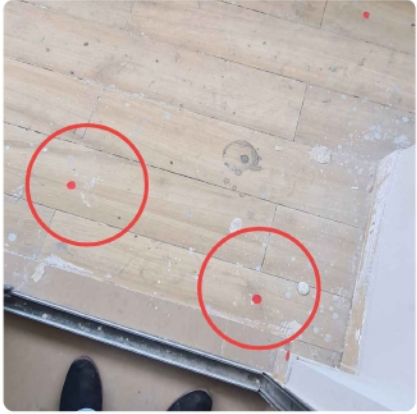
3	Hollowness or debonding observed in floor tile

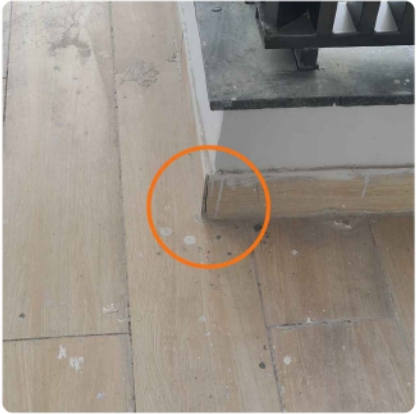
14.13.2. Bedroom 1 Balcony | Minor

No.	Issue	Picture
1	Grouting application not done

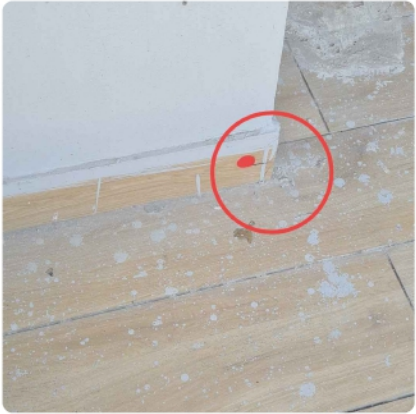
14.14.1. Bedroom 2 Balcony | Major

No.	Issue	Picture
1	Crack observed on skirting tile

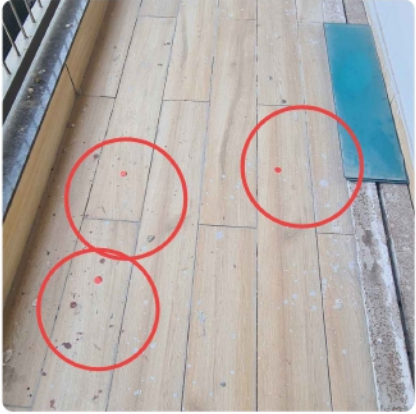
2	Hollowness or debonding observed in floor tile

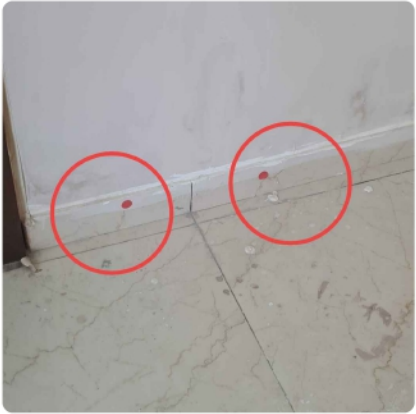
14.15.1. Servant Room | Major

No.	Issue	Picture
1	Hollowness observed on skirting tile

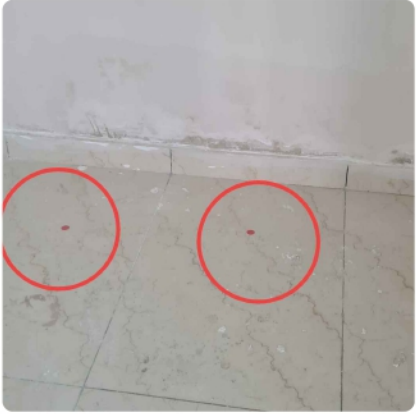
2	Hollowness or debonding observed in floor tile

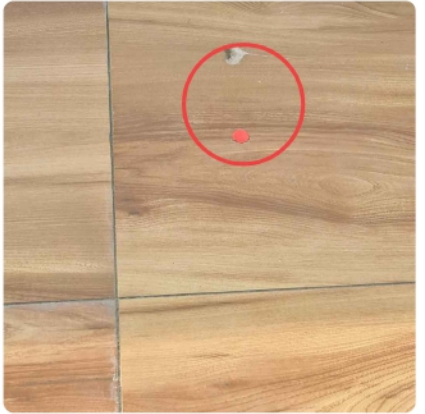
14.17.1. Terrace | **Major**

No.	Issue	Picture
1	Crack / damage / bend observed in floor tile

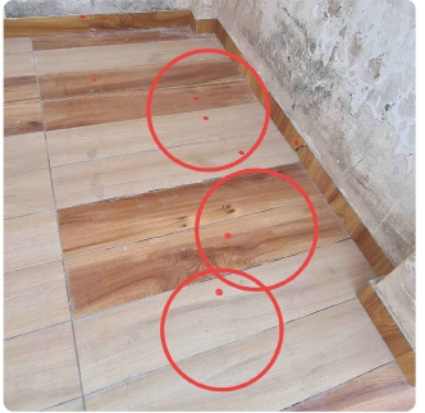
2	Hollowness or debonding observed in floor tile

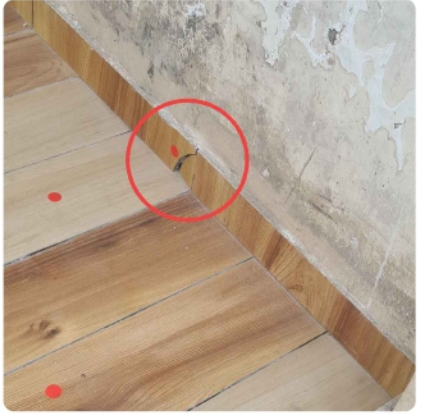
3	Crack observed on skirting tile

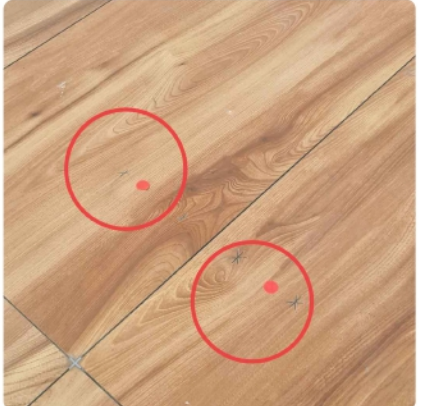
4	Crack / damage / bend observed in floor tile

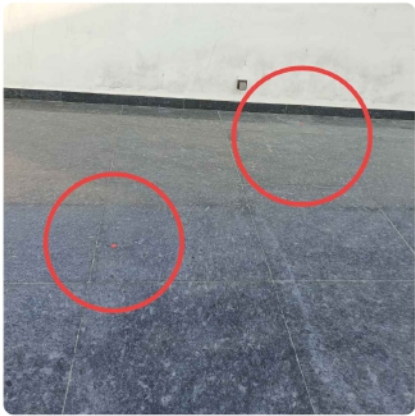
14.17.1. Terrace | Major

No.	Issue	Picture
9	Crack / damage / bend observed in floor tile

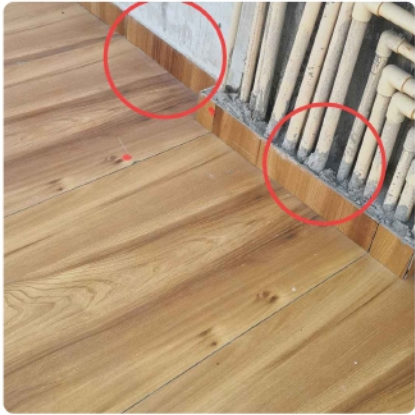
10	Gap observed between wall surface and skirting tile

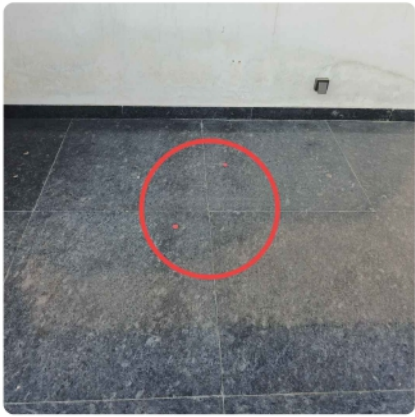
11	Crack / damage / bend observed in floor tile

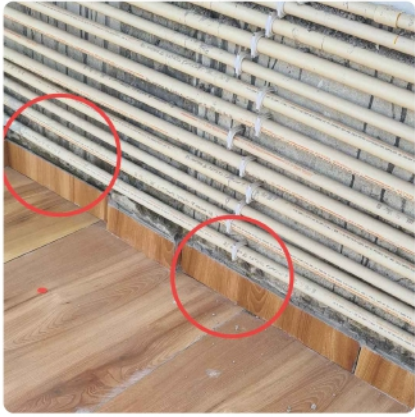
12	Gap observed between wall surface and skirting tile

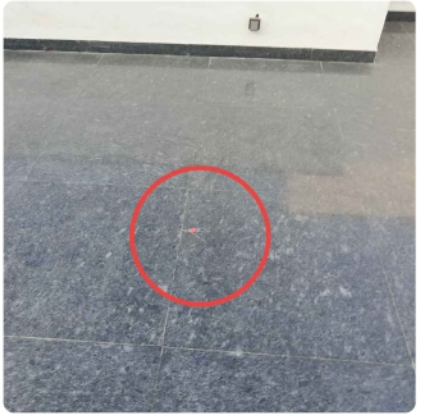
14.17.1. Terrace | **Major**

No.	Issue	Picture
13	Crack / damage / bend observed in floor tile

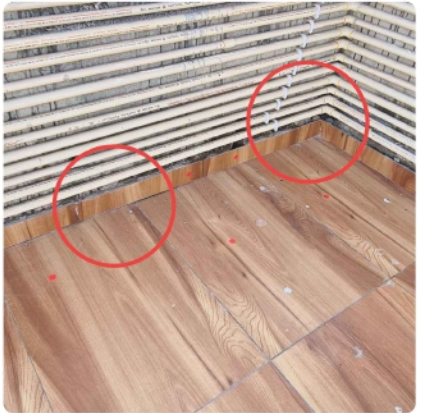
14	Gap observed between wall surface and skirting tile

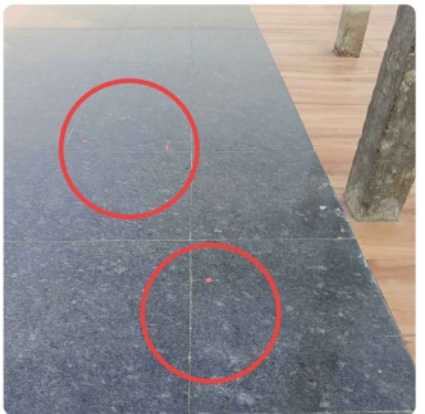
15	Crack / damage / bend observed in floor tile

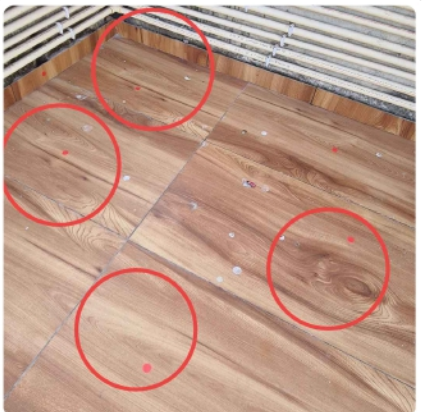
16	Hollowness or debonding observed in floor tile

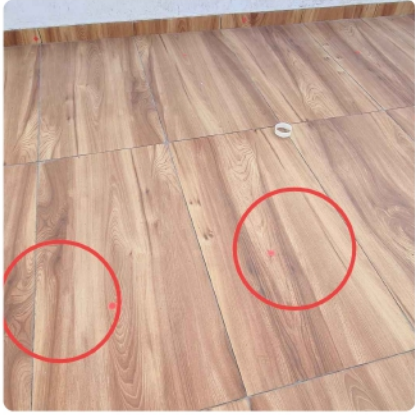
20	Hollowness or debonding observed in floor tile

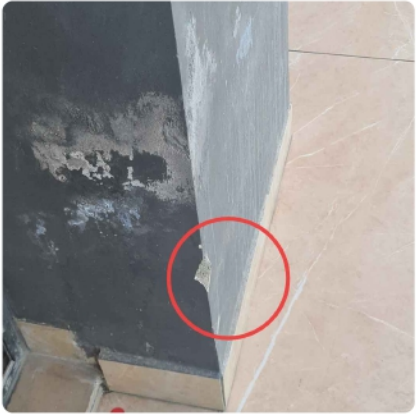
26.9.1. Living Room Balcony 1 | Major

No.	Issue	Picture
1	Crack/damage observed in wall

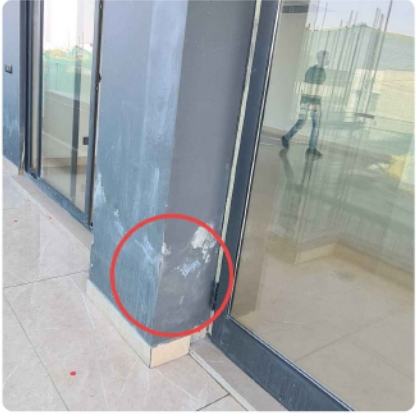
3	Dry water mark observed on wall surface

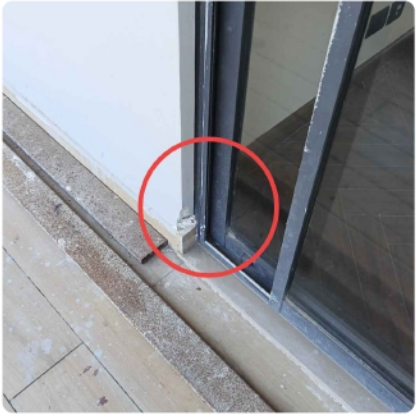
26.14.1. Bedroom 2 Balcony | Major

No.	Issue	Picture
1	Crack/damage observed in wall

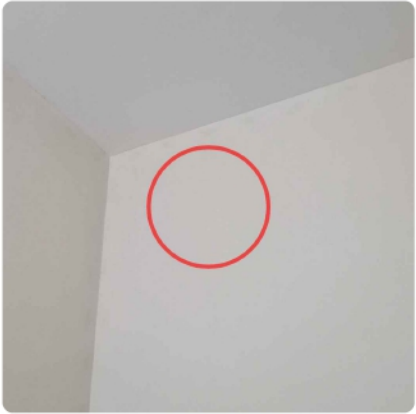
26.15.1. Servant Room | Major

No.	Issue	Picture
9	Crack observed on wall surface

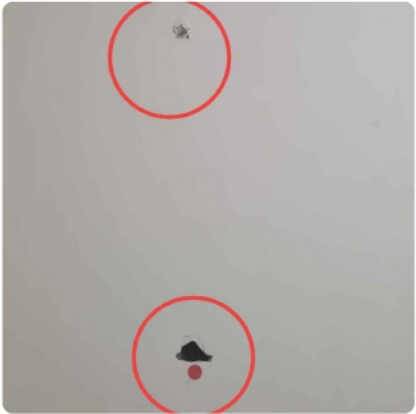
10	Crack/damage observed in wall

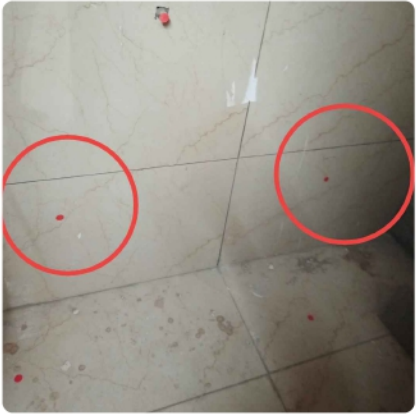
26.16.1. Servant Room Toilet | Major

No.	Issue	Picture
5	Tiles sounding hollow or debonding observed in wall tiles

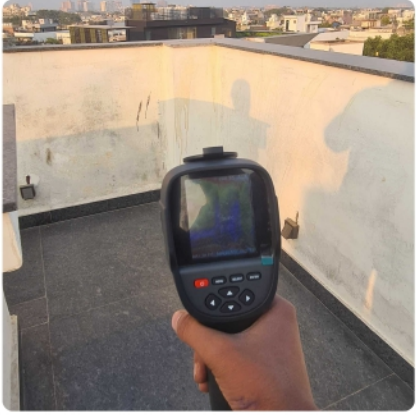
3	Dampness observed on wall	 
4	Dampness observed on wall

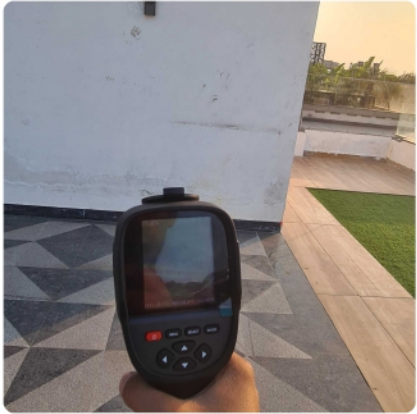
26.17.1. Terrace | **Major**

No.	Issue	Picture
9	Dampness observed on wall

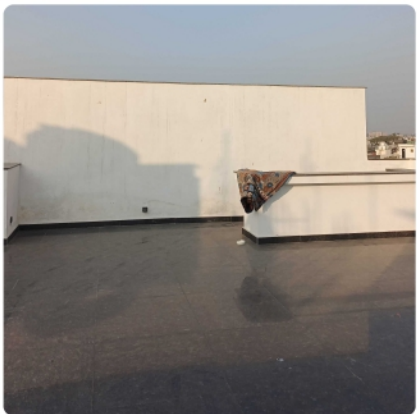
11	Shade of paint not uniform at all places

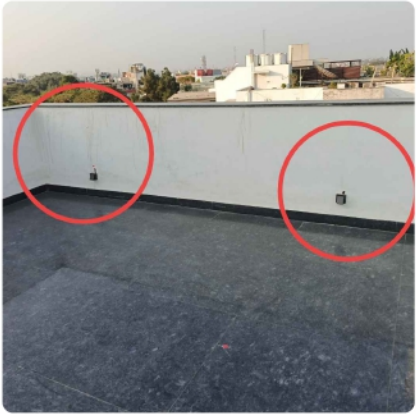
26.17.1. Terrace | Major

No.	Issue	Picture
17	Crack/damage observed in wall

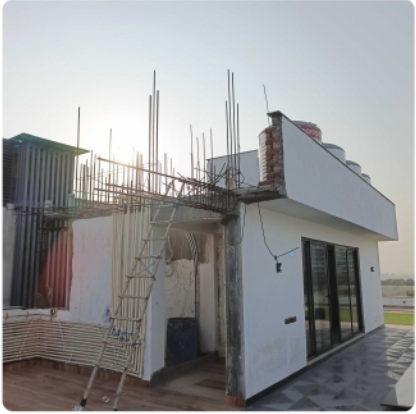
18	Crack/damage observed in wall	 
19	Civil work found incomplete.

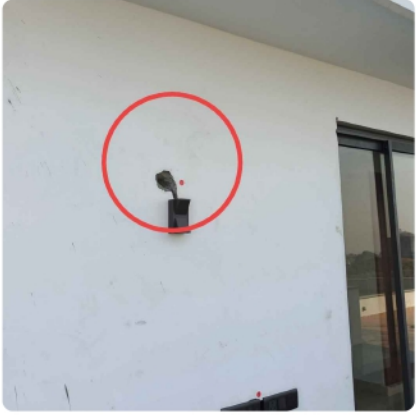
20	Damage observed on wall

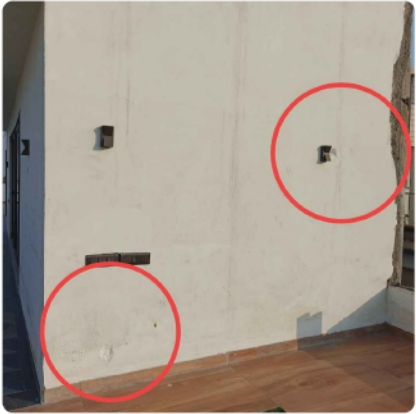
26.17.1. Terrace | Major

No.	Issue	Picture
21	Damage observed on wall

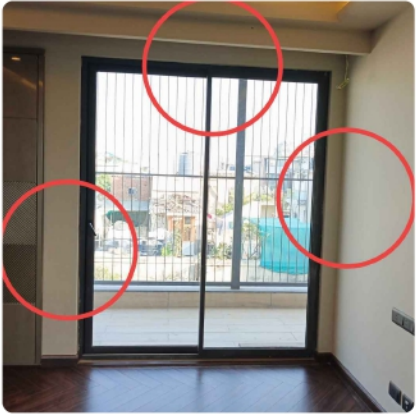
28.2.1. Bedroom 3 | Major

No.	Issue	Picture
1	Gap between frame not sealed with sealant from internal or external side

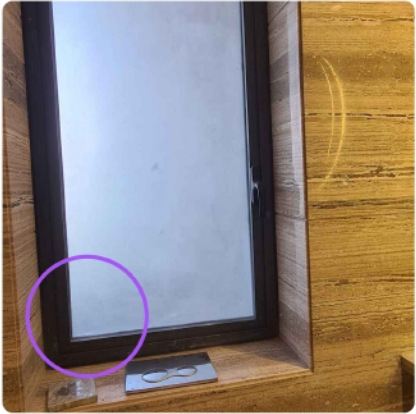
28.4.1. Toilet 1 | Cosmetic

No.	Issue	Picture
1	Paint mark needs to be clean

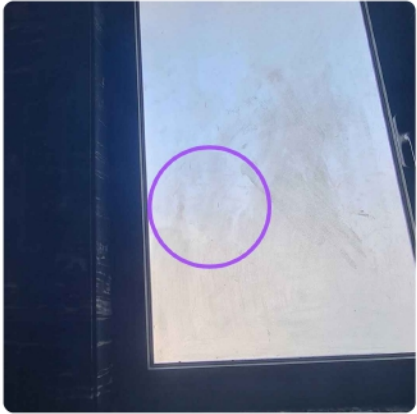
28.5.1. Toilet 2 | Cosmetic

No.	Issue	Picture
1	Stains need to be clean

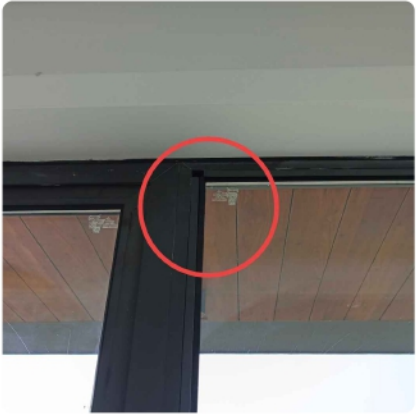
28.7.1. Living | Major

No.	Issue	Picture
1	Window frame or shutter bent or damaged

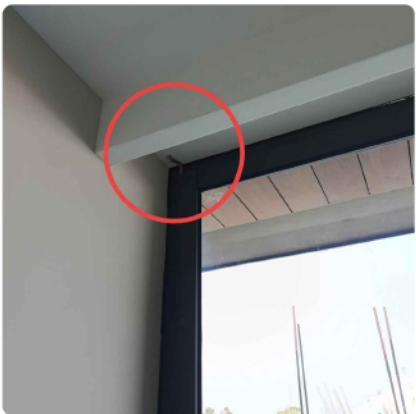
3	Rubber gasket not fixed properly.

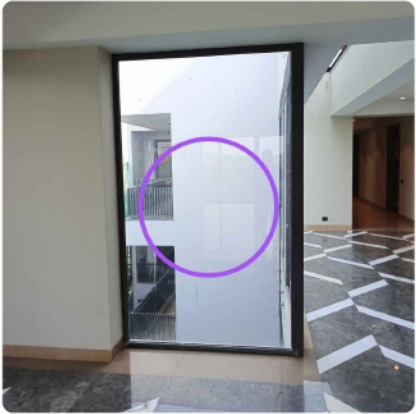
28.7.2. Living | Minor

No.	Issue	Picture
1	Scratches observed on window glass
