HOME INSPECTION

Inspection Date
27/06/24

Address
**414, Malviya
Nagar, New Delhi**

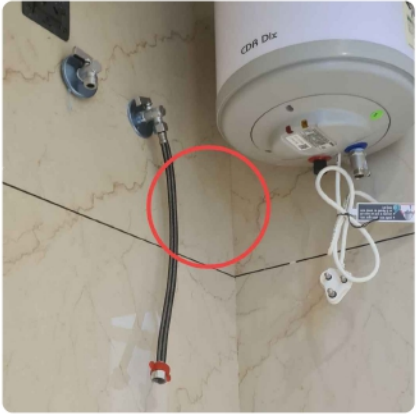
4.2.1. Kitchen | Major

No.	Issue	Picture
1	Geyser fittings not satisfactorily

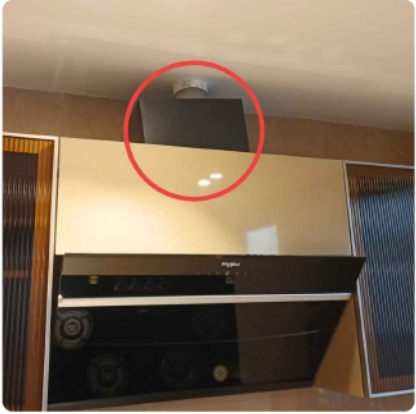
2	Chimney fittings not satisfactory.

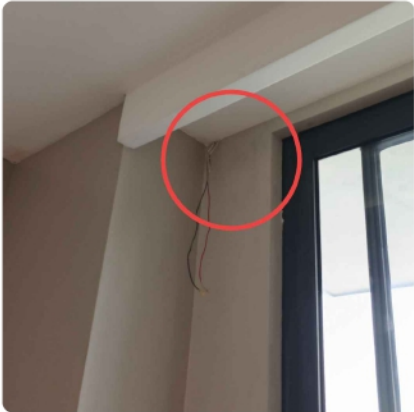
8.1.1. Bedroom 1 | Major

No.	Issue	Picture
1	Cut outs needs to be sealed properly

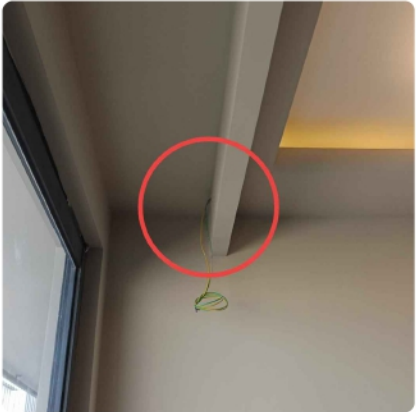
8.2.1. Bedroom 3 | Major

No.	Issue	Picture
1	Cut outs needs to be sealed properly

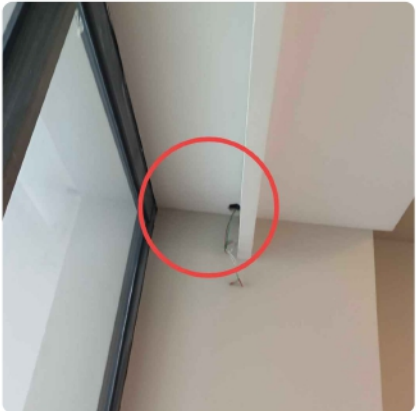
2	Cut outs needs to be sealed properly

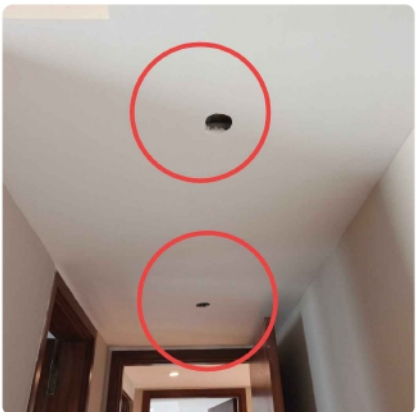
3	Ceiling lights not fixed

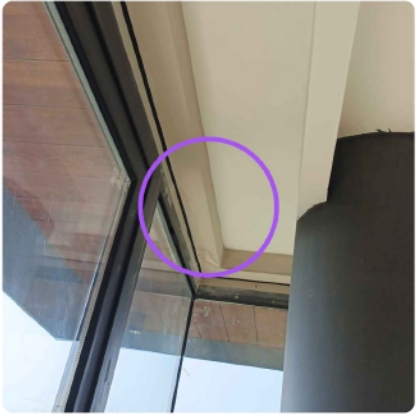
8.3.1. Bedroom 4 | Major

No.	Issue	Picture
1	Paint work not satisfactory

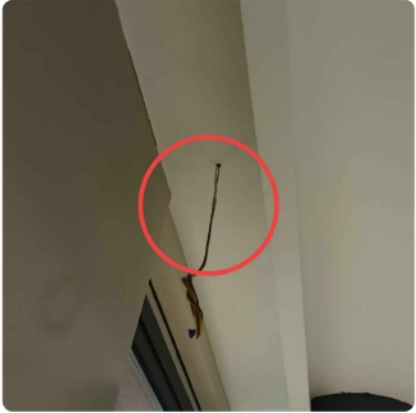
2	Cut outs needs to be sealed properly

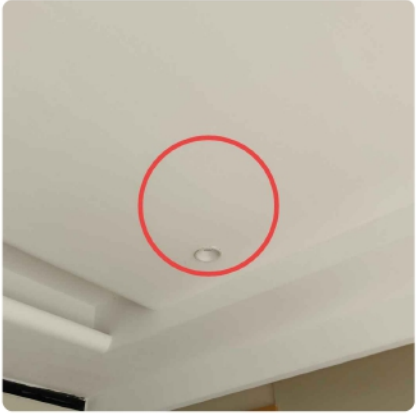
3	Ceiling light not fixed properly

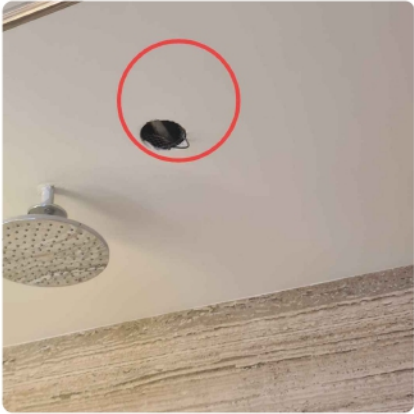
8.4.1. Toilet 1 | Major

No.	Issue	Picture
1	Cut out needs to be sealed properly

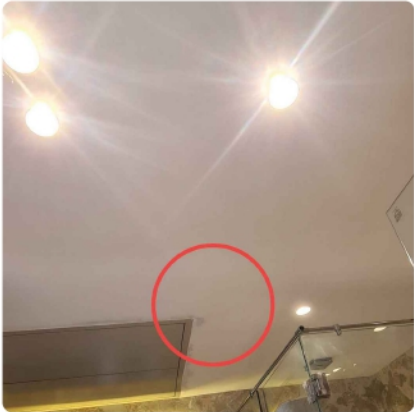
8.6.1. Toilet 4 | Major

No.	Issue	Picture
1	Paint mark observed on ceiling surface

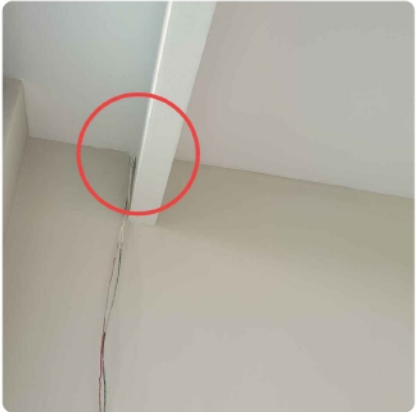
8.7.1. Living | Major

No.	Issue	Picture
1	Cut out needs to be sealed properly

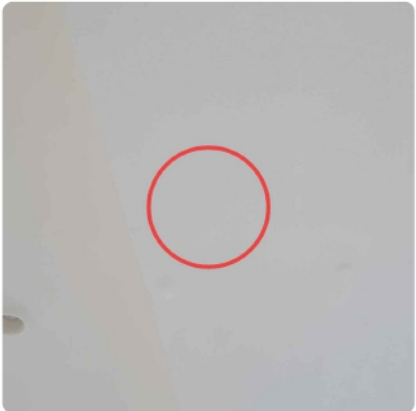
2	Peeling observed on ceiling surface

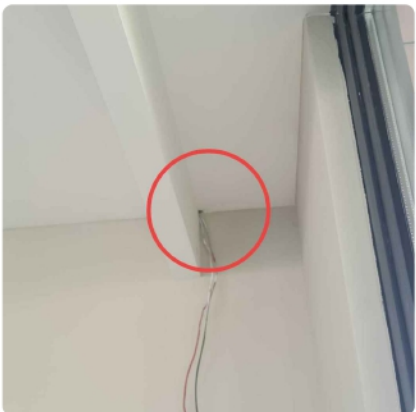
3	Cut out needs to be sealed properly

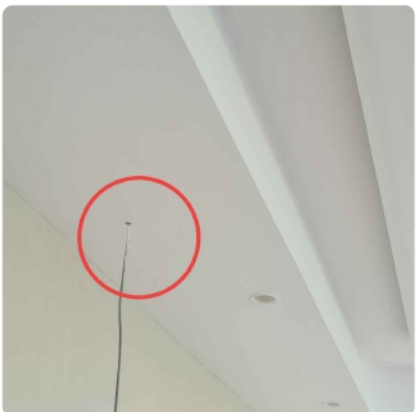
4	Cut out needs to be sealed properly

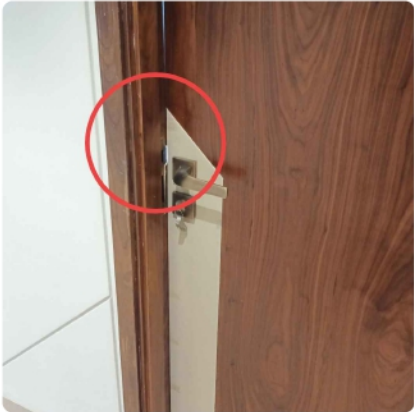
10.1.1. Bedroom 1 | Major

No.	Issue	Picture
1	Door shutter not closing properly.

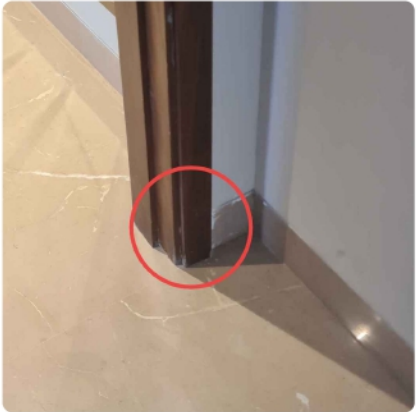
10.2.1. Bedroom 3 | Major

No.	Issue	Picture
1	Crack observed on door frame

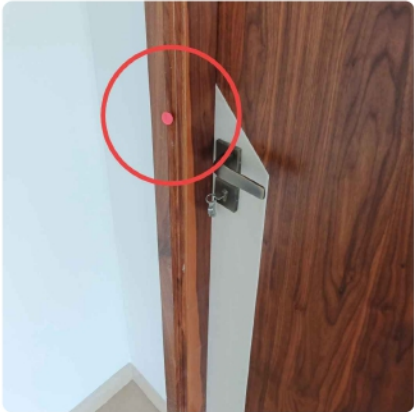
10.3.1. Bedroom 4 | Major

No.	Issue	Picture
1	Gap observed in door frame

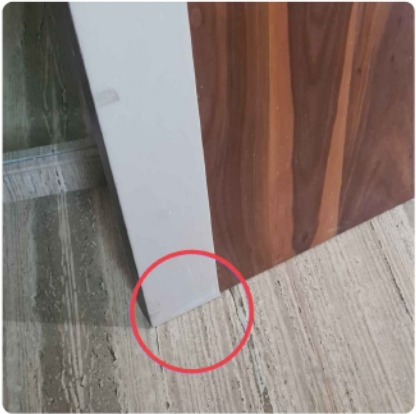
2	Door fittings not satisfactorily

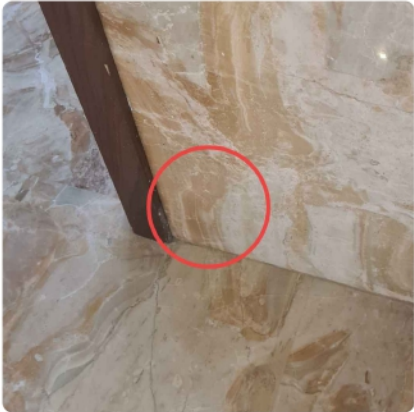
10.6.1. Toilet 4 | Major

No.	Issue	Picture
1	Gap observed between door frame and wall surface.

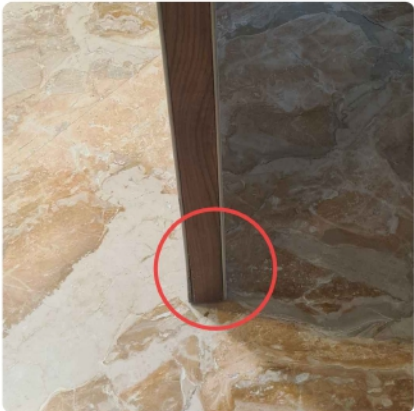
2	Door fittings not satisfactorily

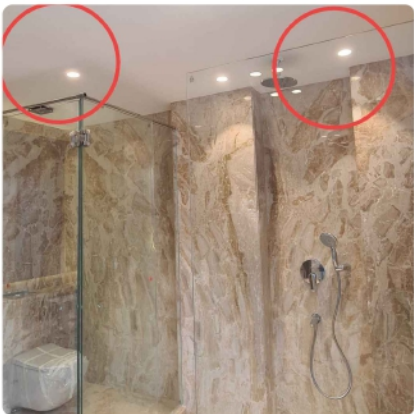
3	Glass fittings work not finished

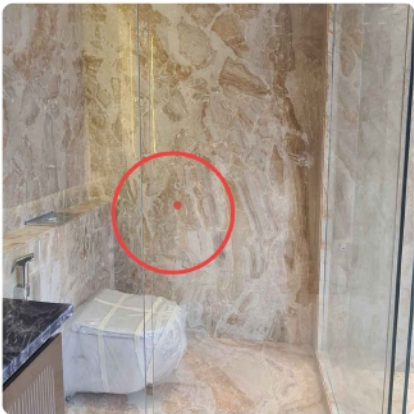
4	Glass door handle not fixed

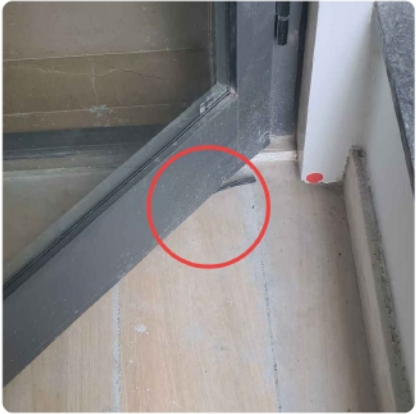
10.8.2. Utility Balcony | Minor

No.	Issue	Picture
1	Rubber gasket not fixed properly.

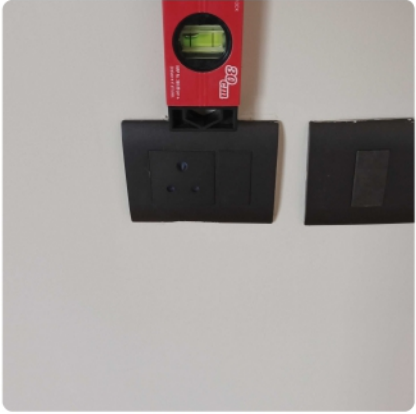
2	Switch board not fixed in line or level

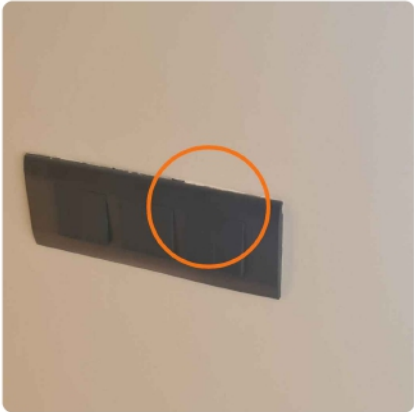
12.2.2. Bedroom 3 | Minor

No.	Issue	Picture
1	Gap observed between switch plate & wall/tile surface

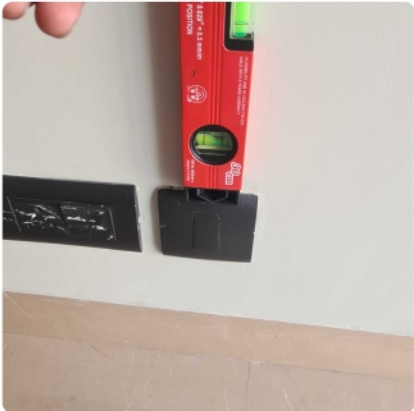
2	Switch board not fixed in line or level

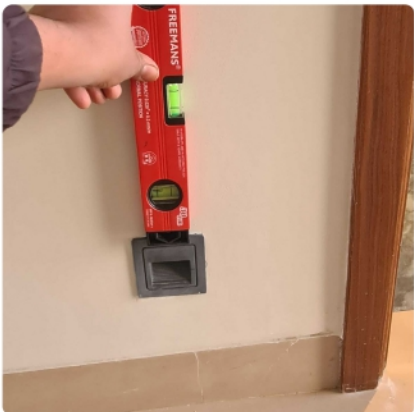
3	Switch board not fixed in line or level

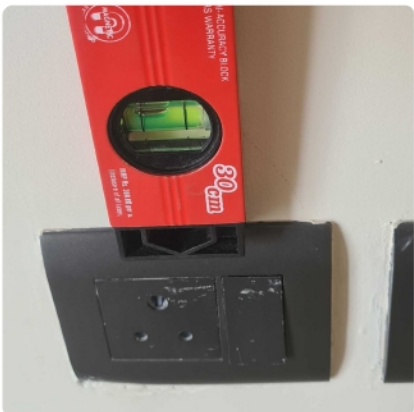
4	Switch board not fixed in line or level

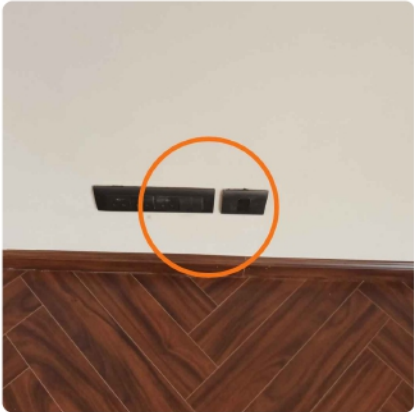
12.2.2. Bedroom 3 | Minor

No.	Issue	Picture
5	Gap observed between switch plate & wall/tile surface

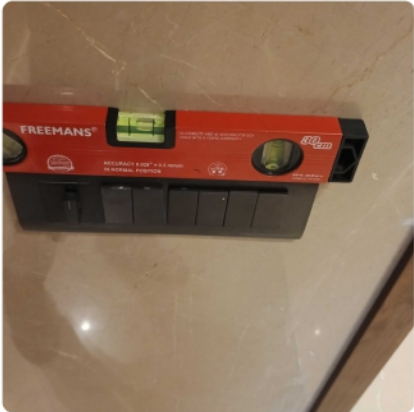
12.4.2. Kitchen | Minor

No.	Issue	Picture
1	Switch board not fixed in line or level

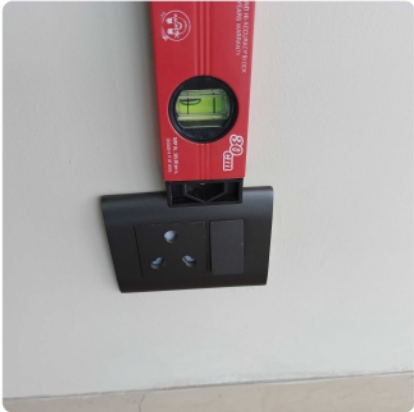
12.5.1. Living | **Minor**

No.	Issue	Picture
1	Switch board not fixed in line or level

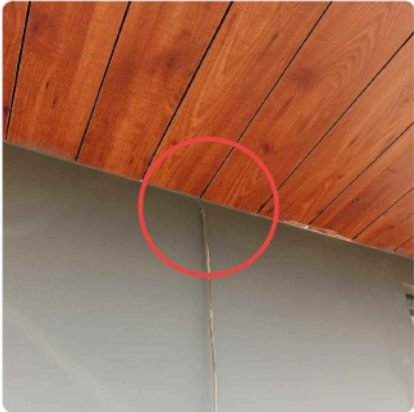
12.6.1. Living Room Balcony 2 | Major

No.	Issue	Picture
1	Cut outs needs to be sealed properly

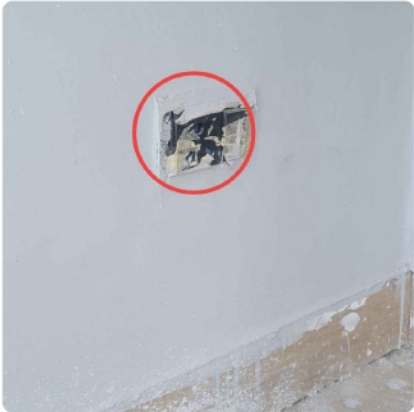
12.7.1. Bedroom 1 Balcony | Major

No.	Issue	Picture
1	Damage Observed on switch board

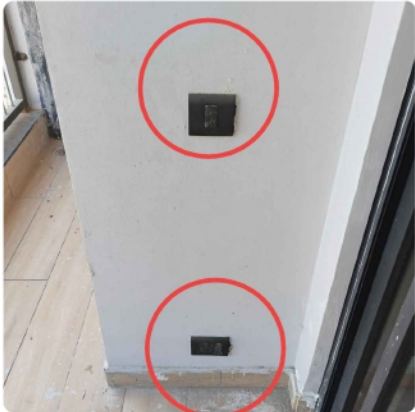
12.8.1. Bedroom 2 Balcony | Minor

No.	Issue	Picture
1	Gap observed between switch plate & wall/tile surface

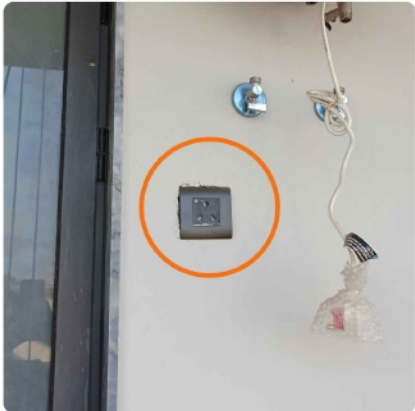
2	Gap observed between switch plate & wall/tile surface

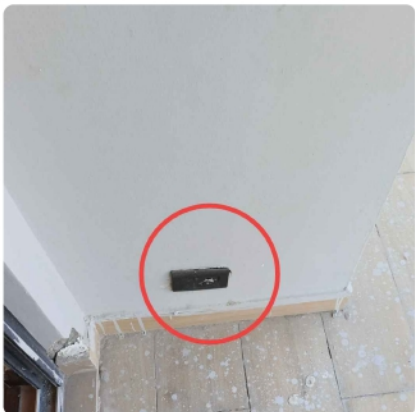
3	Gap observed between switch plate & wall/tile surface

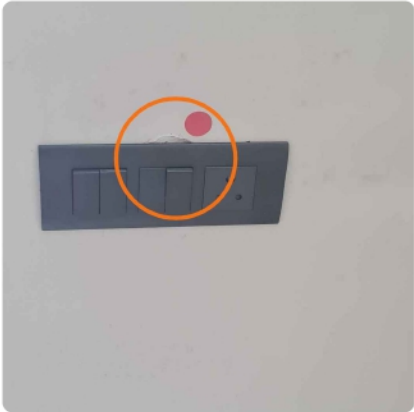
12.9.1. Servant Room | Minor

No.	Issue	Picture
1	Gap observed between switch plate & wall/tile surface

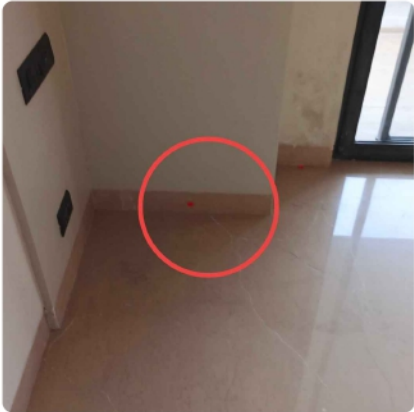
14.1.1. Bedroom 1 | Major

No.	Issue	Picture
1	Skirting is sounding hollow

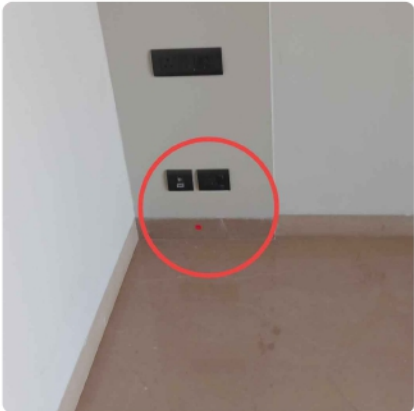
2	Skirting is sounding hollow

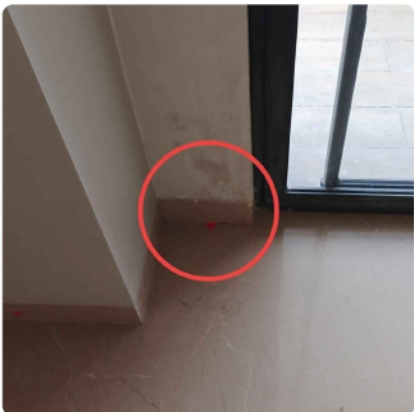
3	Improperly filled gaps between skirting & floor tile

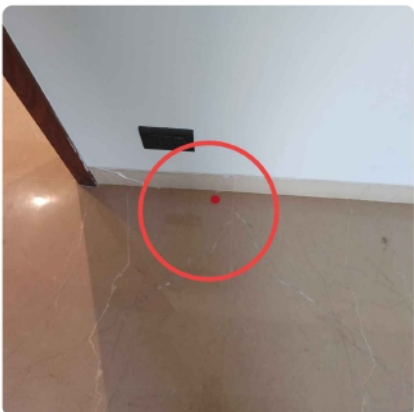
4	Crack / damage / bend observed in floor tile

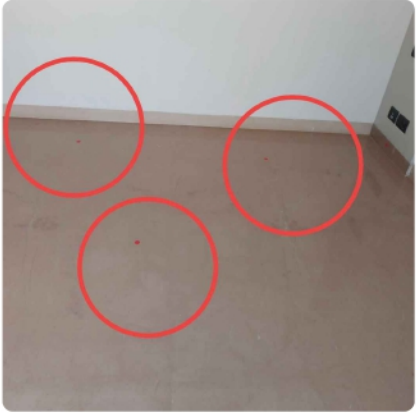
6	Hollowness or debonding observed in floor tile

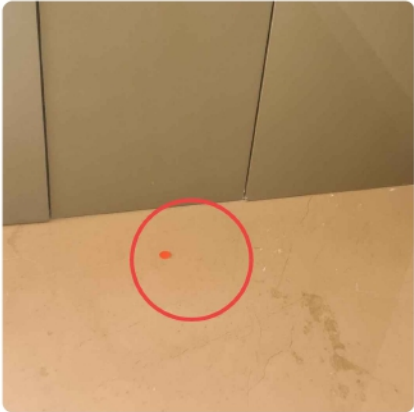
14.2.1. Bedroom 3 | Major

No.	Issue	Picture
5	Hollowness or debonding observed in floor tile

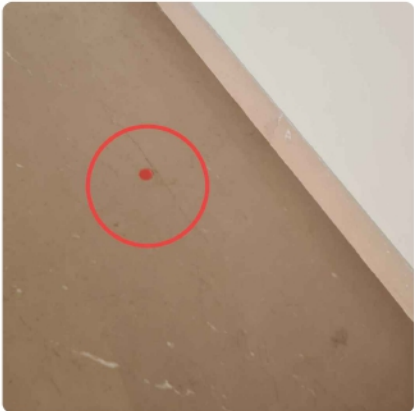
6	Hollowness or debonding observed in floor tile

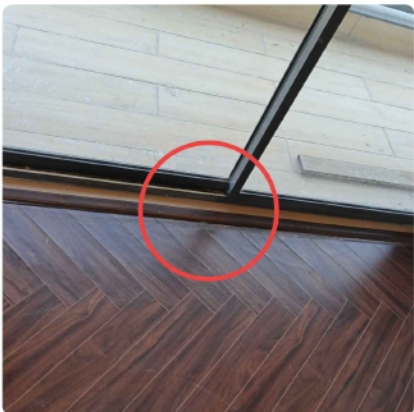
7	Reducer not fixed properly

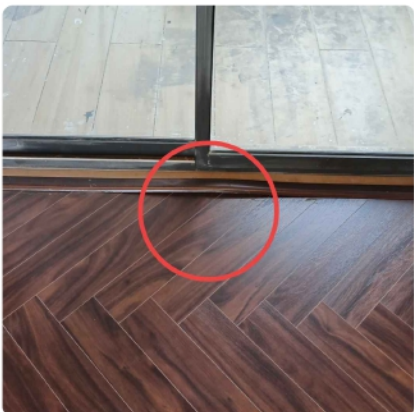
8	Reducer not fixed properly

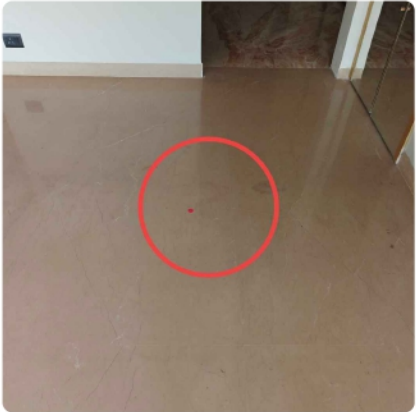
14.3.1. Bedroom 4 | Major

No.	Issue	Picture
1	Hollowness or debonding observed in floor tile

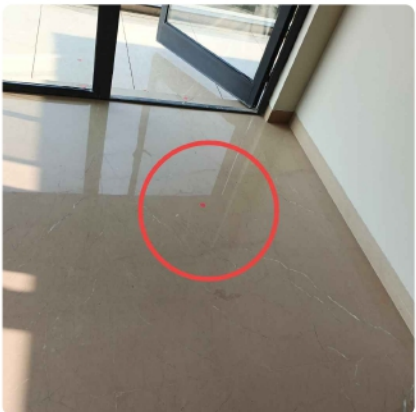
3	Hollowness or debonding observed in floor tile

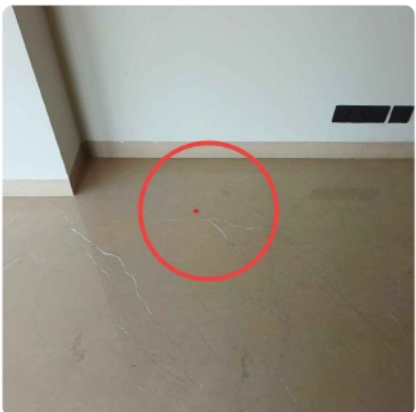
4	Hollowness or debonding observed in floor tile

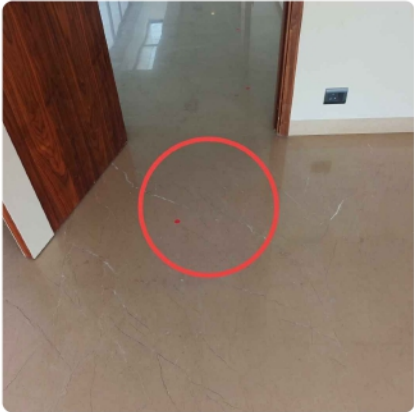
14.3.1. Bedroom 4 | Major

No.	Issue	Picture
5	Hollowness or debonding observed in floor tile

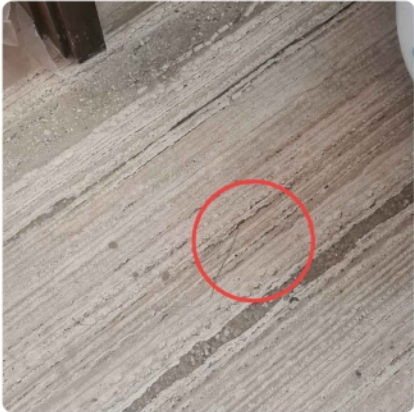
14.4.1. Toilet 1 | Major

No.	Issue	Picture
1	Crack / damage / bend observed in floor tile

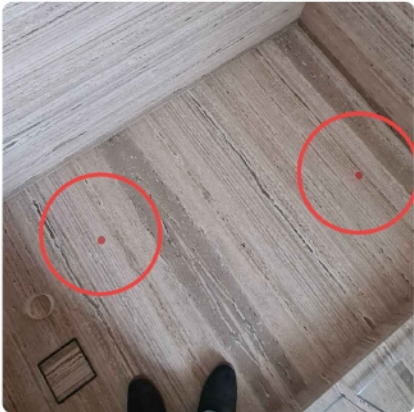
2	Hollowness or debonding observed in floor tile

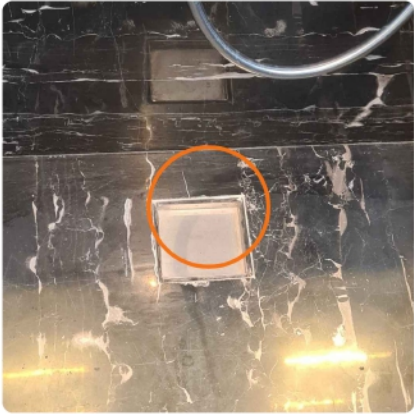
14.5.1. Toilet 2 | Major

No.	Issue	Picture
1	Nahant trap not fixed properly

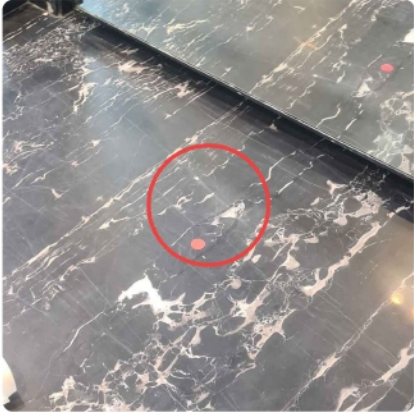
2	Hollowness or debonding observed in floor tile

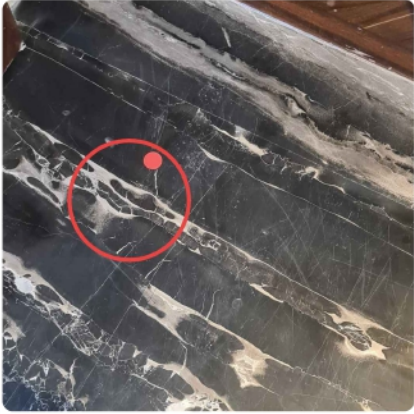
3	Hollowness or debonding observed in floor tile

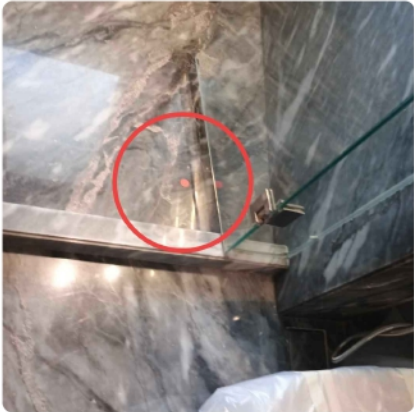
14.6.1. Toilet 3 | Major

No.	Issue	Picture
1	Hollowness or debonding observed in floor tile

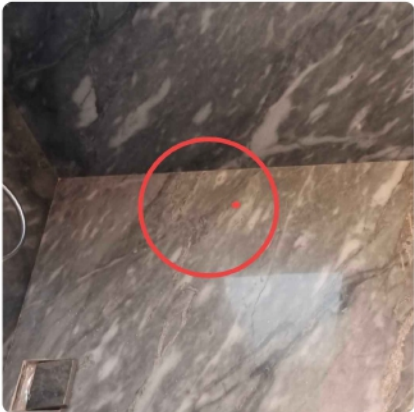
2	Hollowness or debonding observed in floor tile

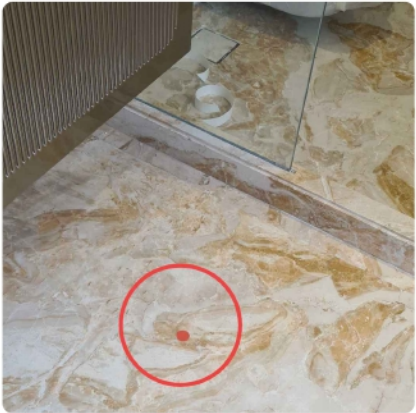
2	Hollowness or debonding observed in floor tile

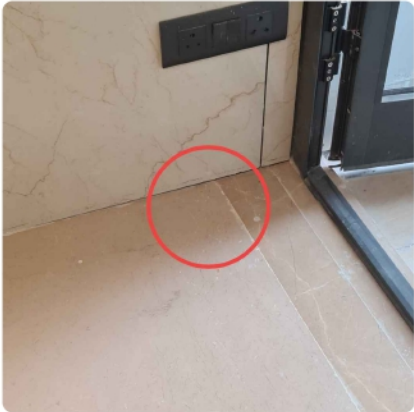
14.8.1. Kitchen | Major

No.	Issue	Picture
1	Gap observed between wall and flooring tile

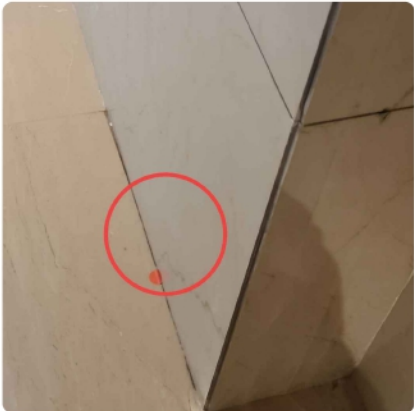
2	Gap observed between wall and flooring tile

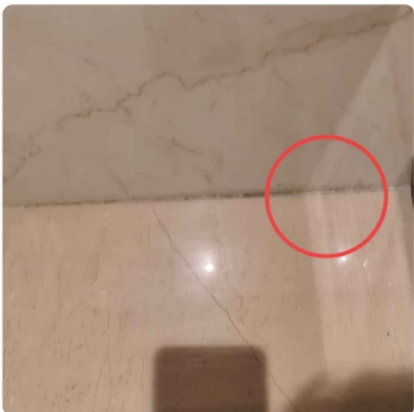
3	Gap observed between wall and flooring tile

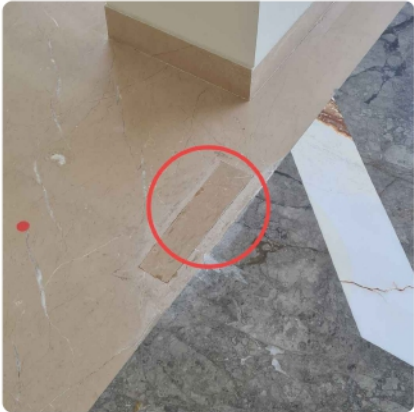
14.9.1. Living | Major

No.	Issue	Picture
1	Crack / damage / bend observed in floor tile

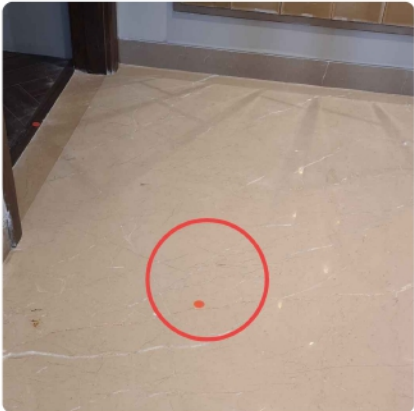
2	Hollowness or debonding observed in floor tile

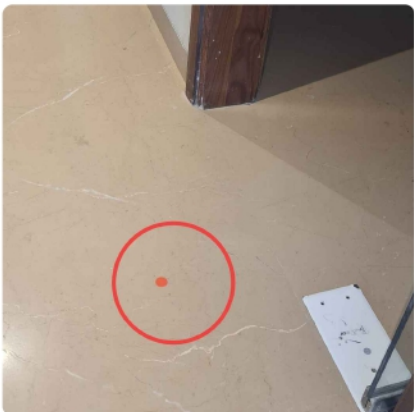
3	Hollowness or debonding observed in floor tile

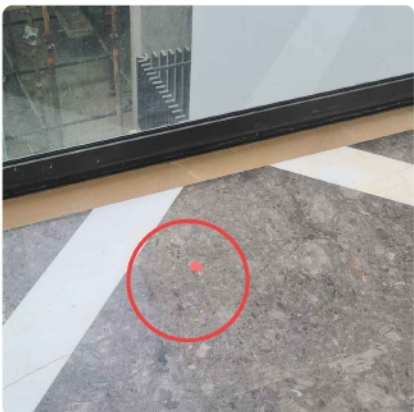
4	Hollowness or debonding observed in floor tile

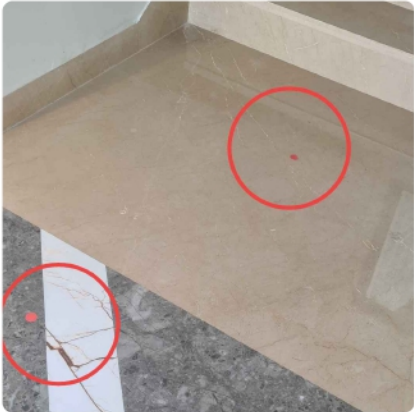
14.9.1. Living | Major

No.	Issue	Picture
5	Hollowness or debonding observed in floor tile

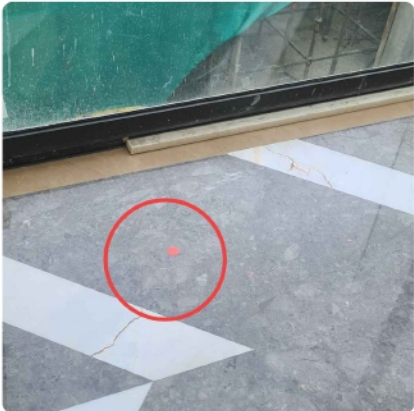
6	Hollowness or debonding observed in floor tile

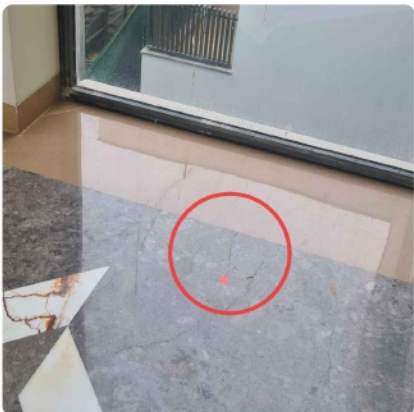
7	Hollowness or debonding observed in floor tile

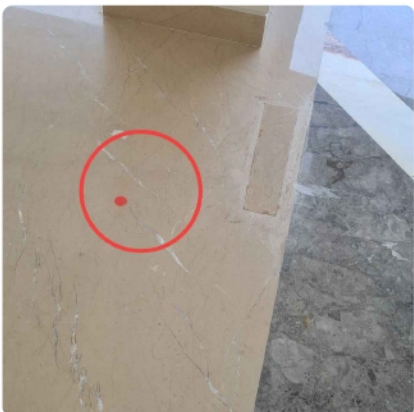
8	Hollowness or debonding observed in floor tile

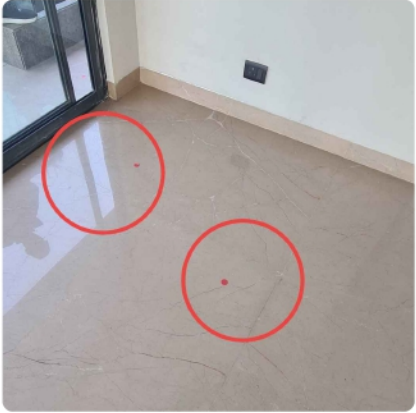
10	Hollowness or debonding observed in floor tile

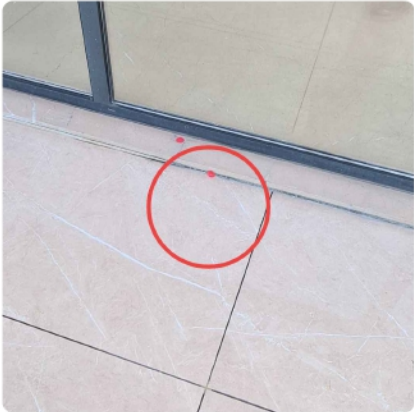
No.	Issue	Picture
9	Gap observed in skirting

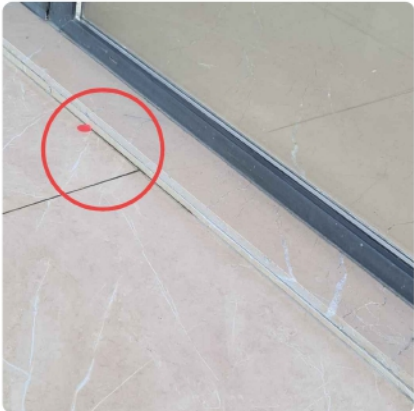
10	Gap observed in skirting

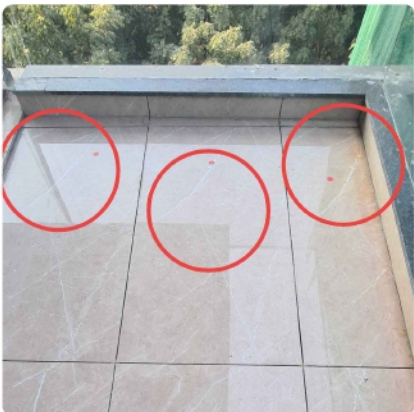
11	Hollowness or debonding observed in floor tile

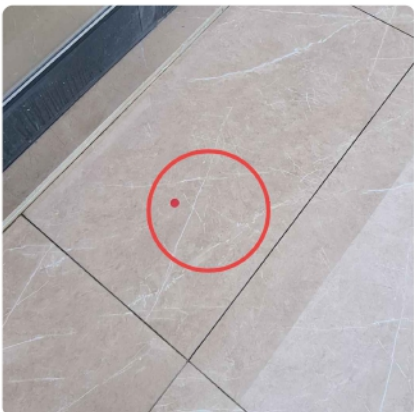
12	Hollowness or debonding observed in floor tile

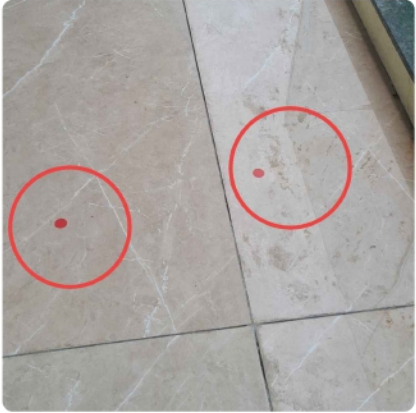
14	Hollowness or debonding observed in floor tile

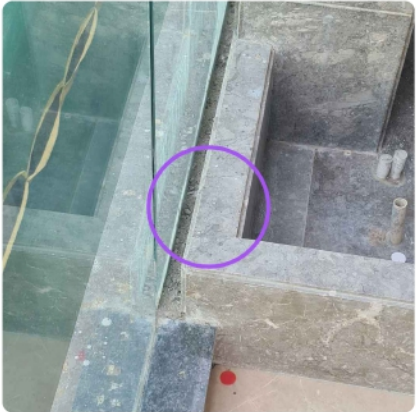
No.	Issue	Picture
1	Stains need to be clean

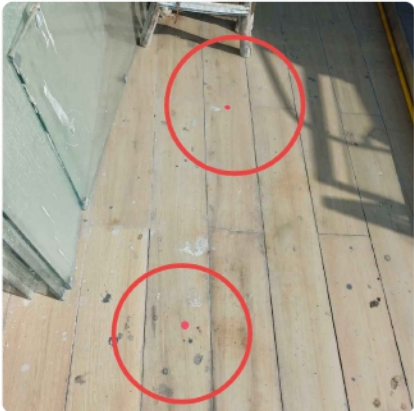
2	Hollowness or debonding observed in floor tile

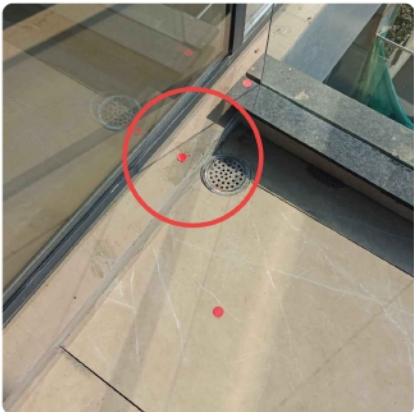
4	Crack / damage / bend observed in floor tile

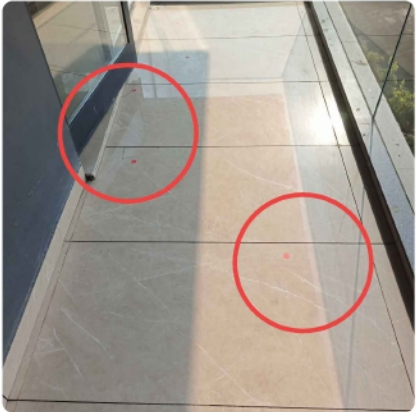
No.	Issue	Picture
5	Crack / damage / bend observed in floor tile

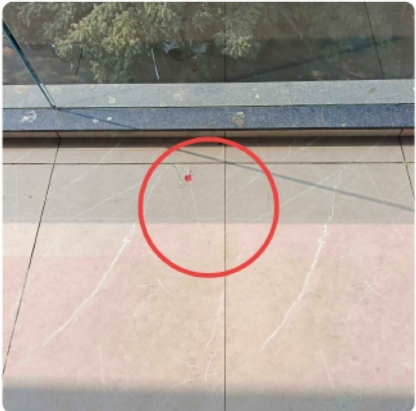
6	Crack / damage / bend observed in floor tile

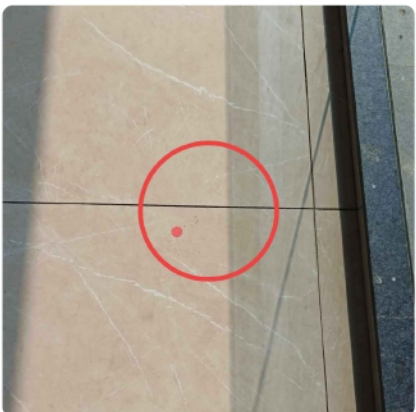
8	Hollowness or debonding observed in floor tile

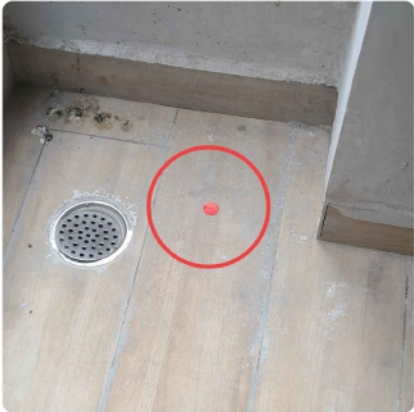
No.	Issue	Picture
1	Hollowness or debonding observed in floor tile

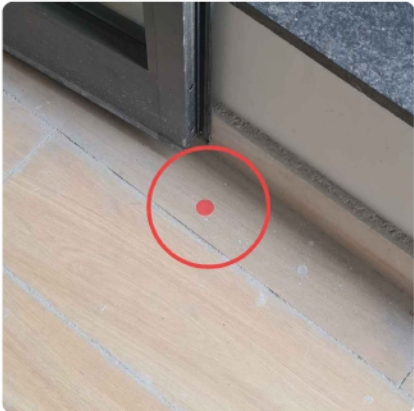
2	Hollowness or debonding observed in floor tile

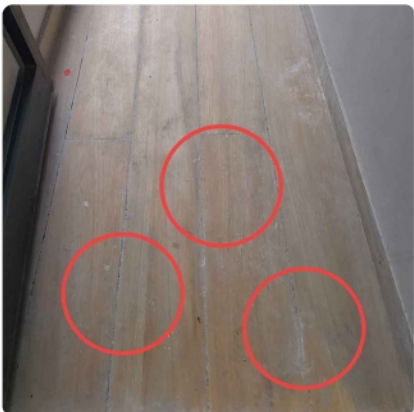
3	Offset observed on flooring tile

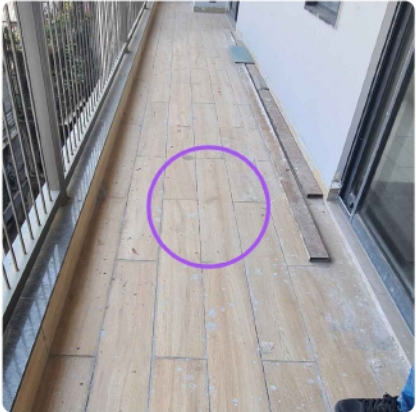
No.	Issue	Picture
1	Deep cleaning needs to be done

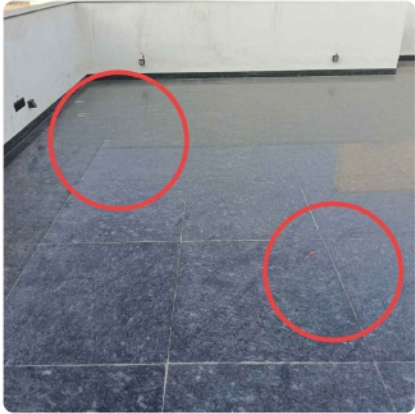
No.	Issue	Picture
17	Crack / damage / bend observed in floor tile

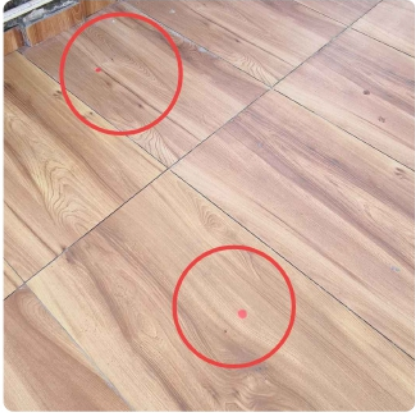
18	Hollowness or debonding observed in floor tile

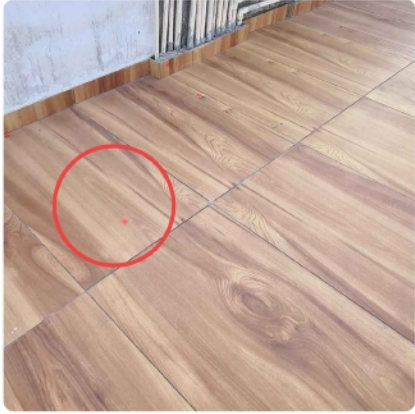
19	Hollowness or debonding observed in floor tile

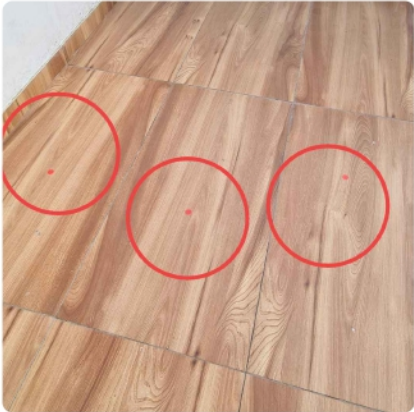
No.	Issue	Picture
21	Hollowness or debonding observed in floor tile

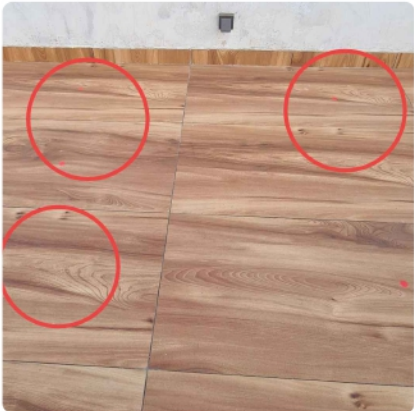
22	Hollowness or debonding observed in floor tile

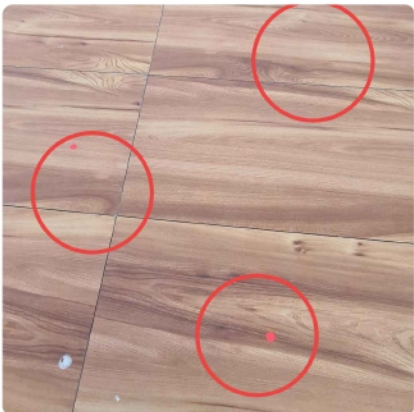
23	Hollowness or debonding observed in floor tile

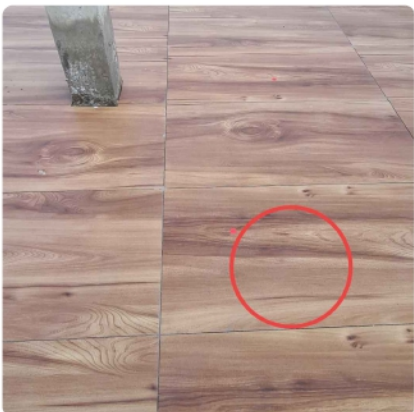
24	Hollowness or debonding observed in floor tile

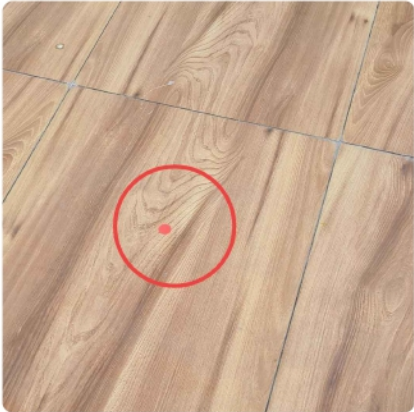
No.	Issue	Picture
25	Hollowness or debonding observed in floor tile

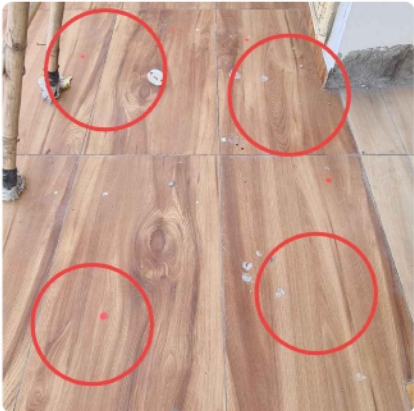
26	Hollowness or debonding observed in floor tile

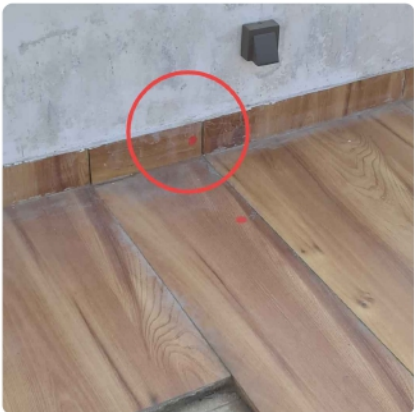
28	Hollowness observed on skirting tile

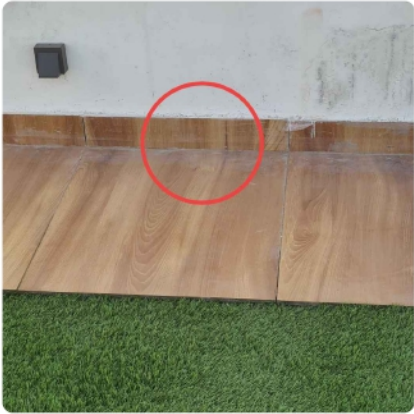
No.	Issue	Picture
29	Gap observed between skirting and flooring tile

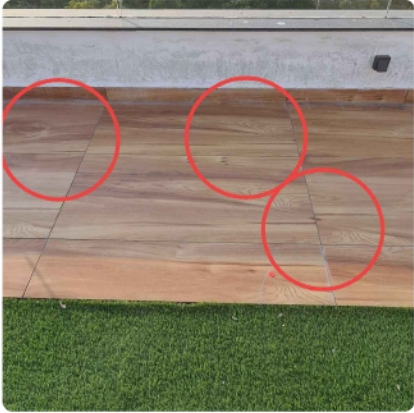
30	Grouting application not satisfactorily

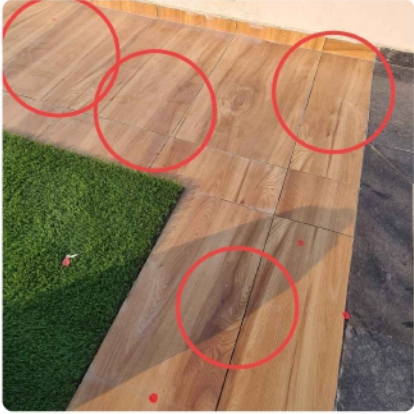
31	Grouting application not satisfactorily

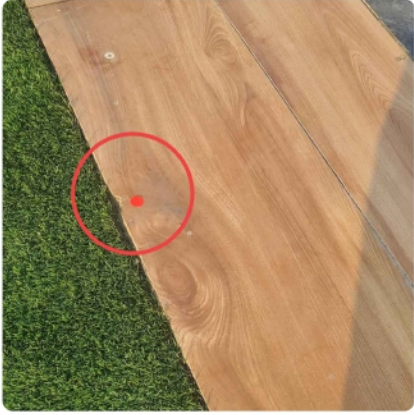
32	Crack / damage / bend observed in floor tile

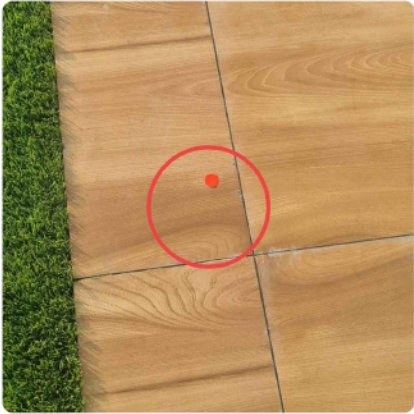
No.	Issue	Picture
37	Crack / damage / bend observed in floor tile

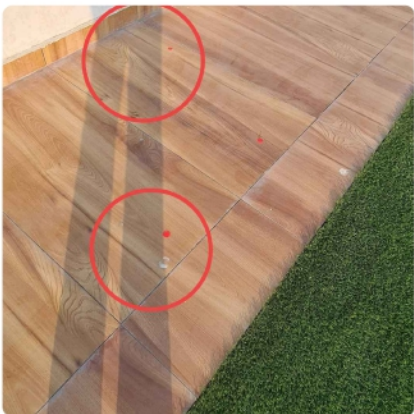
40	Hollowness or debonding observed in floor tile

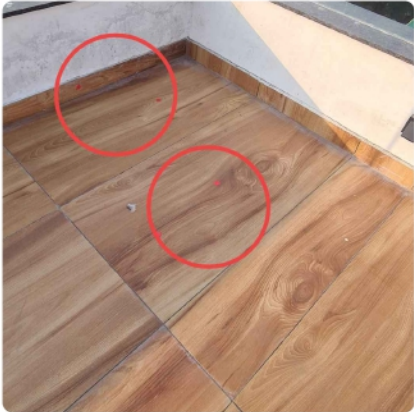
14.17.1. Terrace | Major

No.	Issue	Picture
41	Hollowness or debonding observed in floor tile

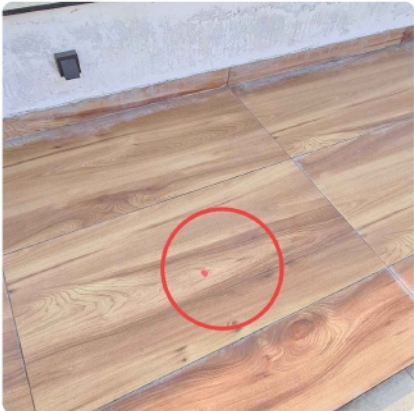
42	Hollowness or debonding observed in floor tile

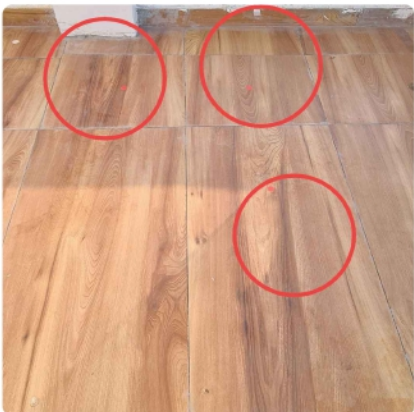
43	Hollowness or debonding observed in floor tile

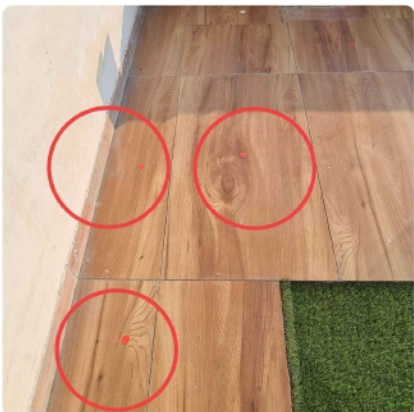
44	Hollowness or debonding observed in floor tile

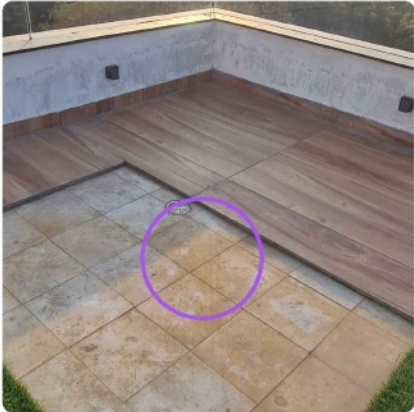
14.17.2. Terrace | Cosmetic

No.	Issue	Picture
1	Stains need to be clean

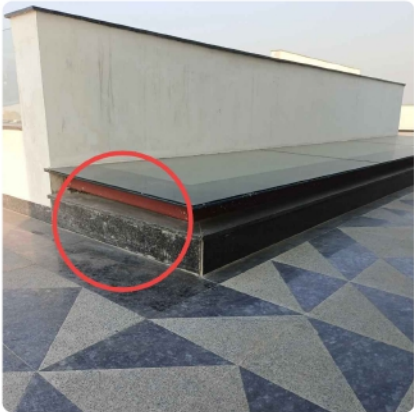
18.1.1. Terrace | Major

No.	Issue	Picture
1	Paint work needs to be done

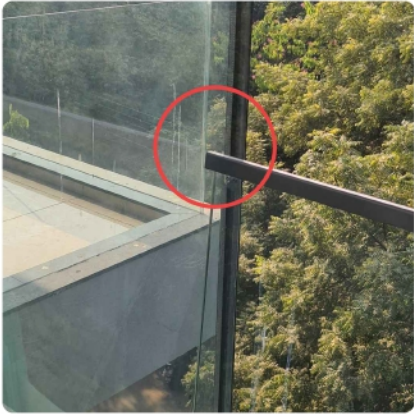
22.1.1. Living Room Balcony 1 | Major

No.	Issue	Picture
1	Handrail cap not provided

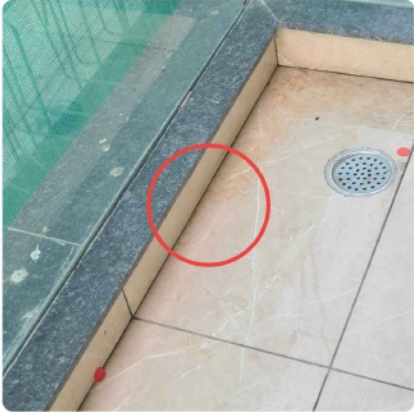
2	Gap observed between skirting and flooring tile

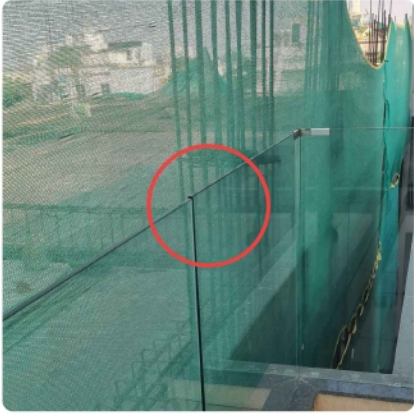
3	Handrail fittings not satisfactorily

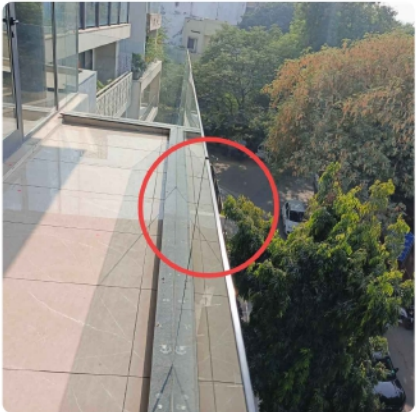
22.2.1. Living Room Balcony 2 | Major

No.	Issue	Picture
1	Handrail not fixed	 
2	Handrail fittings are missing

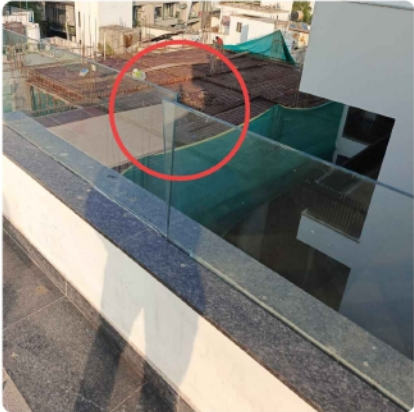
22.5.3. Terrace | Cosmetic

No.	Issue	Picture
1	Hand rail not perfectly in horizontal level from FFL

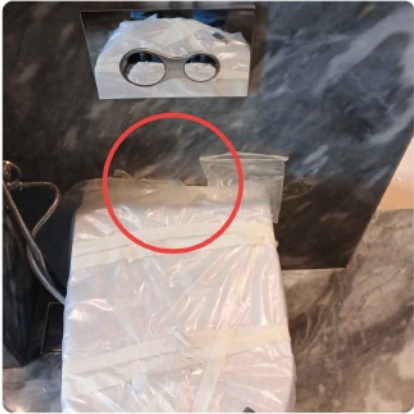
24.1.1. Toilet 3 | Major

No.	Issue	Picture
1	Sealant application not done on WC

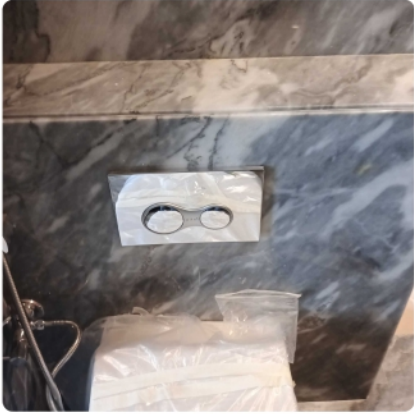
2	Flush not working

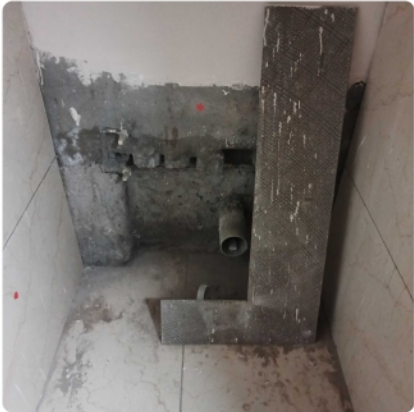
24.2.1. Servant Room Toilet | Major

No.	Issue	Picture
1	Sanitary work found incomplete

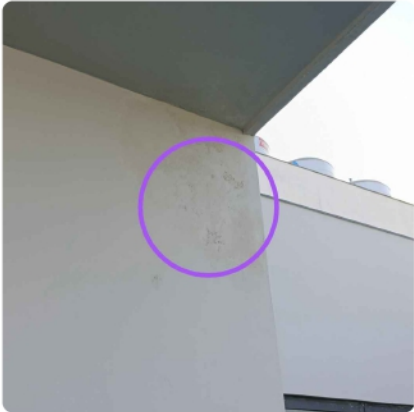
26.1.1. Bedroom 1 | Major

No.	Issue	Picture
1	Dry water Mark observed on wall

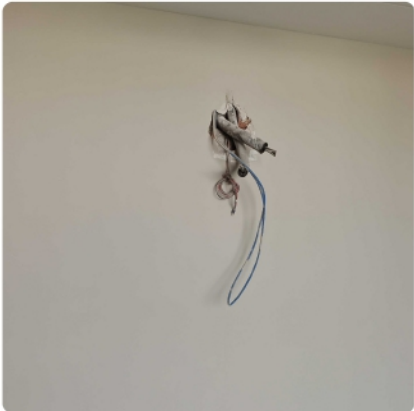
2	AC not fixed

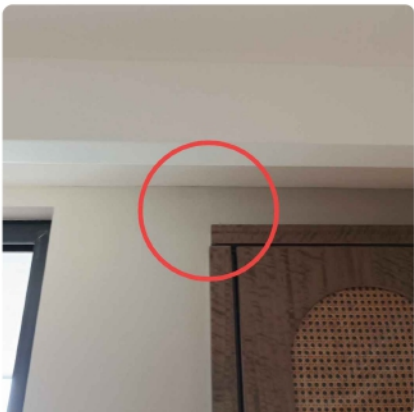
3	Crack/damage observed in wall

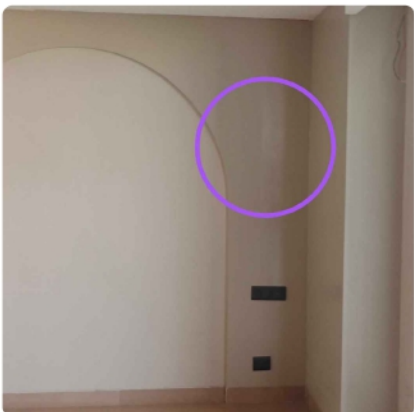
4	Shade of paint not uniform at all places

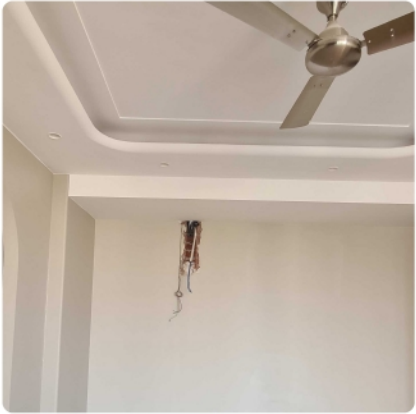
26.2.1. Bedroom 3 | Major

No.	Issue	Picture
5	Paint work needs to be done through out the flat

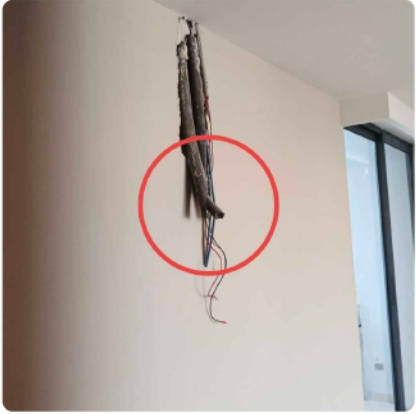
6	AC not fixed

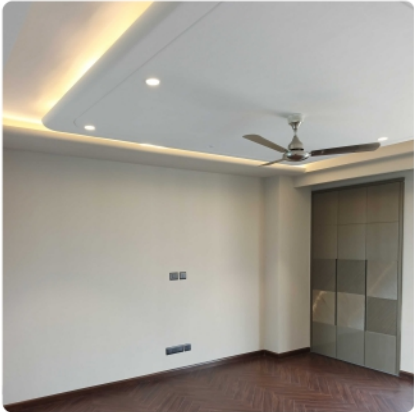
26.2.2. Bedroom 3 | Cosmetic

No.	Issue	Picture
1	Paint work needs to be done through out the flat
