HOME INSPECTION

Inspection Date
27/06/24

Address
**414, Malviya
Nagar, New Delhi**

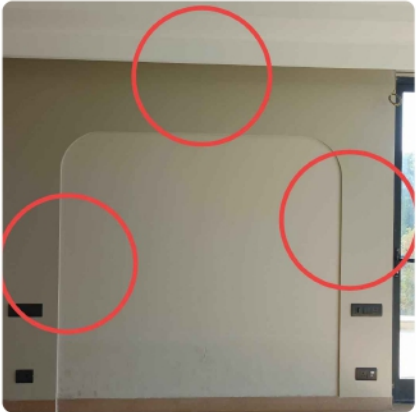
26.3.1. Bedroom 4 | Major

No.	Issue	Picture
1	Crack/damage observed in wall

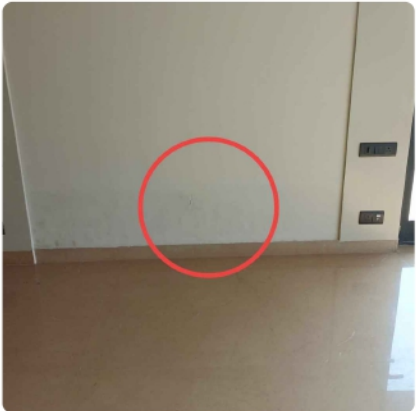
2	Crack/damage observed in wall

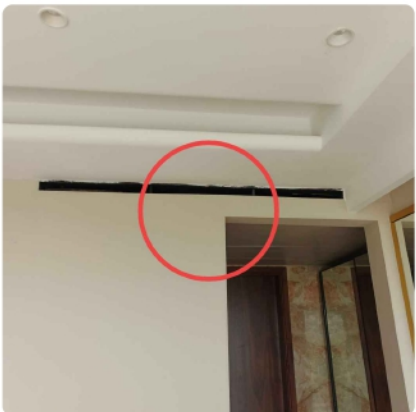
3	Wall work not satisfactory

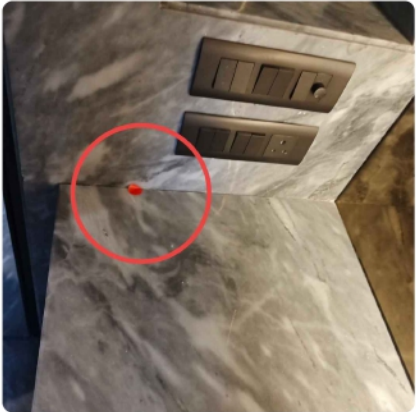
26.5.1. Toilet 3 | Major

No.	Issue	Picture
1	Gap observed between counter top granite and wall tile

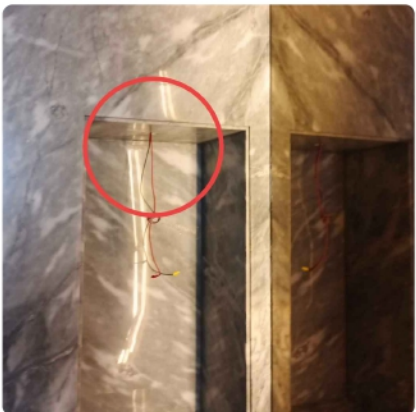
3	Cutouts not properly finished in the tiles

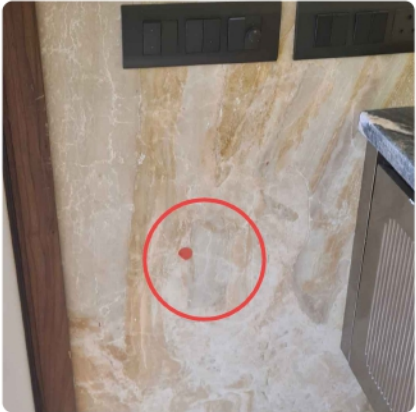
26.6.1. Toilet 4 | Major

No.	Issue	Picture
1	Tiles sounding hollow or debonding observed in wall tiles

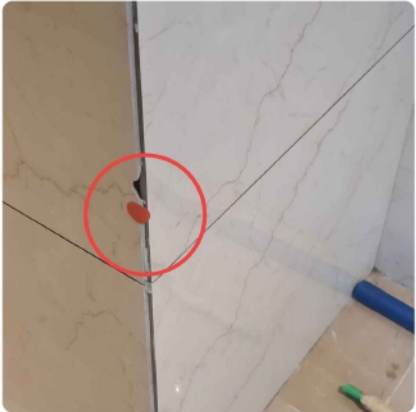
26.7.1. Kitchen | Major

No.	Issue	Picture
1	Crack/damage observed in wall tiles.

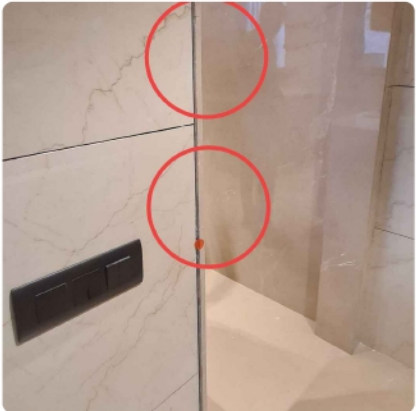
2	Tile fittings not satisfactorily

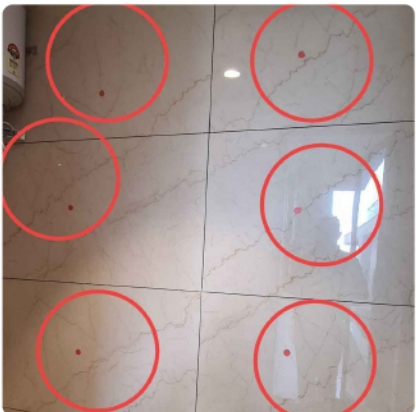
3	Tiles sounding hollow or debonding observed in wall tiles

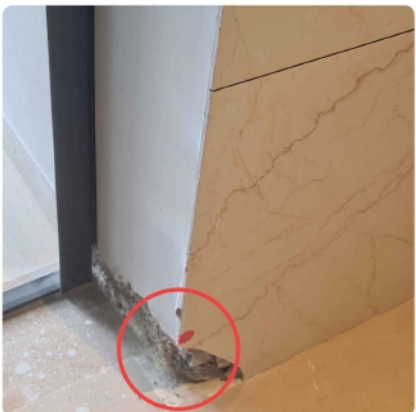
4	Crack/damage observed in wall tiles.

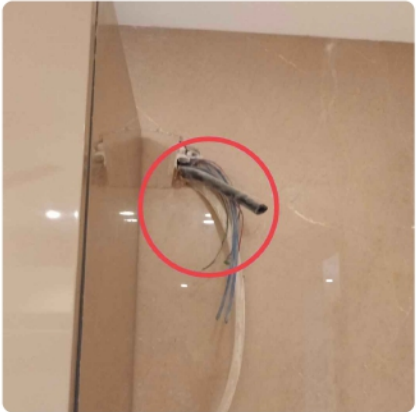
No.	Issue	Picture
5	Cutouts not properly finished in the tiles

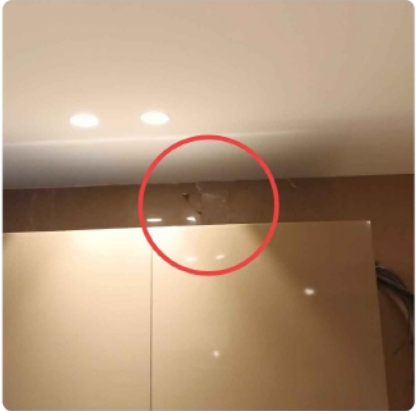
6	Crack/damage/bend observed in wall tiles after fixing

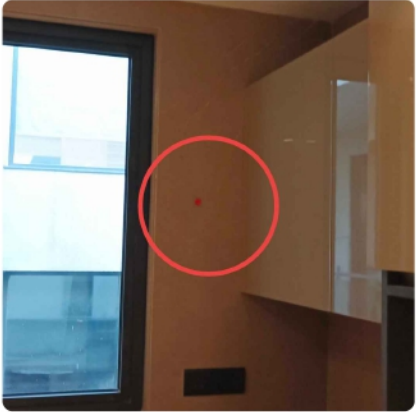
7	Tiles sounding hollow or debonding observed in wall tiles

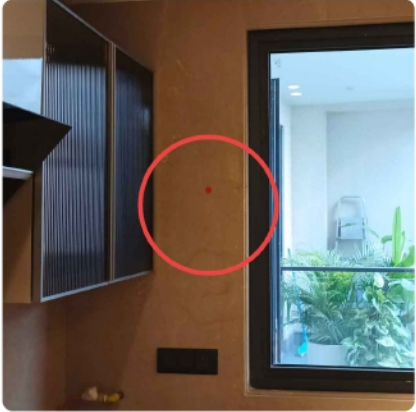
8	Tiles sounding hollow or debonding observed in wall tiles

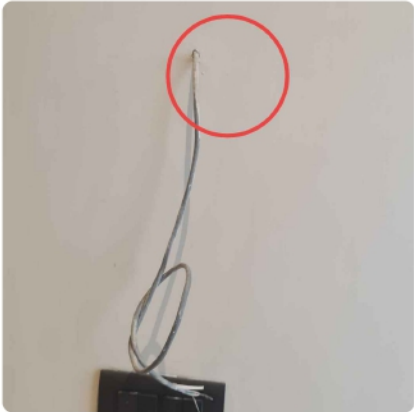
No.	Issue	Picture
1	Cut out needs to be sealed properly

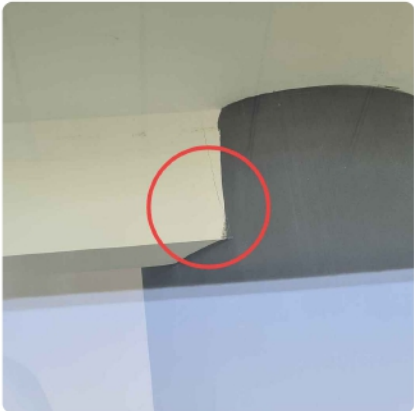
2	Crack observed on beam surface.

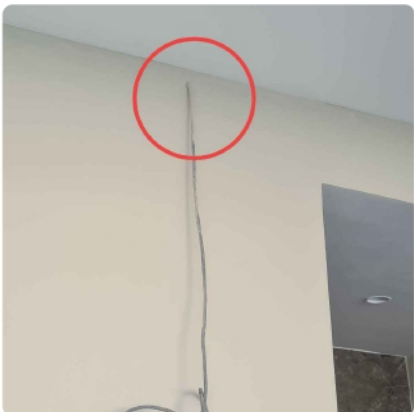
3	Cut out needs to be sealed properly

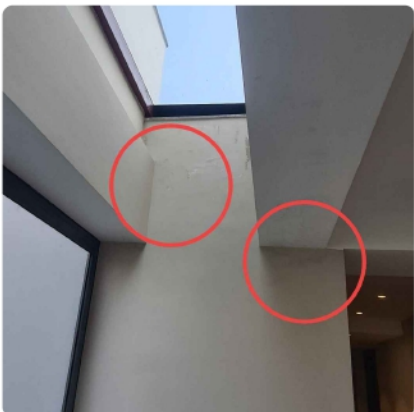
4	Dry water mark observed on wall surface

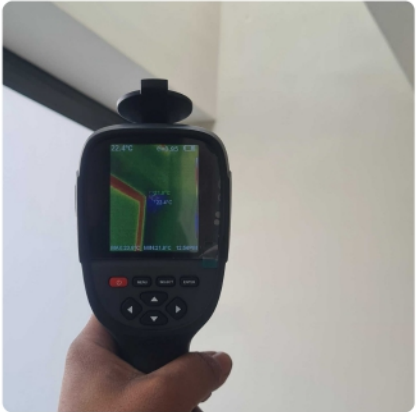
No.	Issue	Picture
5	Dampness observed on wall

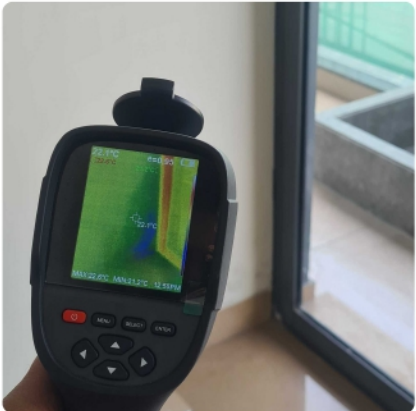
6	Dampness observed on wall

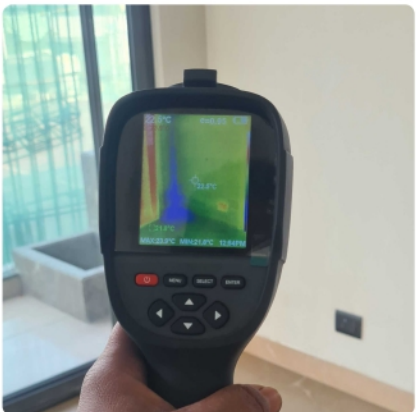
7	Dampness observed on wall

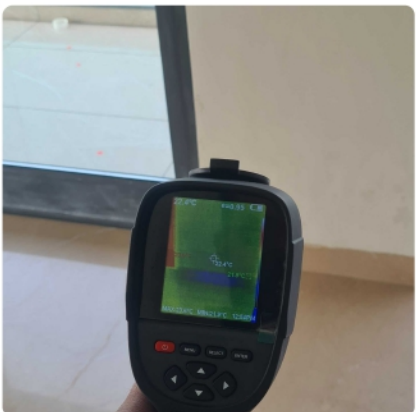
8	Dampness observed on wall

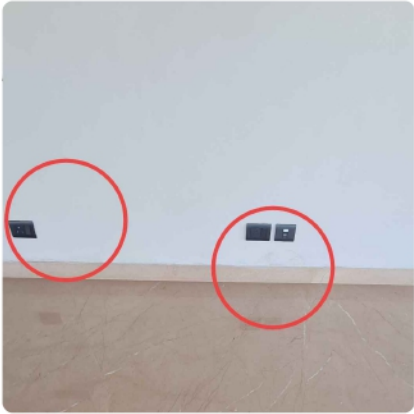
No.	Issue	Picture
9	Dry water mark observed on wall surface

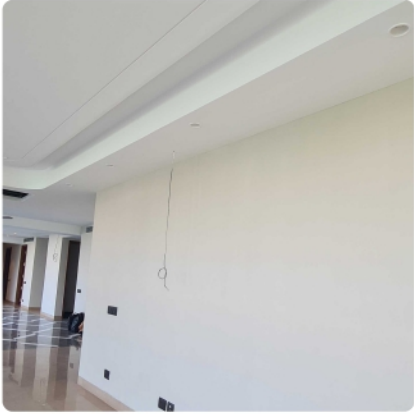
10	Paint work needs to be done through out the flat

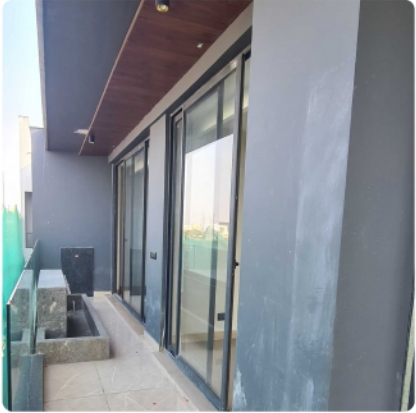
2	Paint work needs to be done through the same

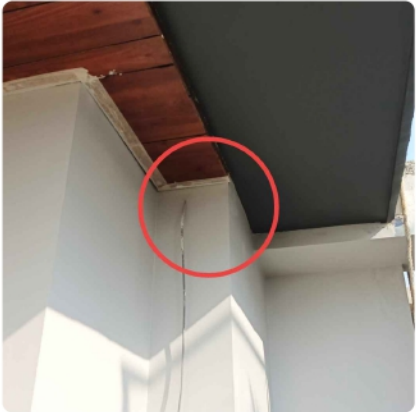
No.	Issue	Picture
1	Cut outs needs to be sealed properly

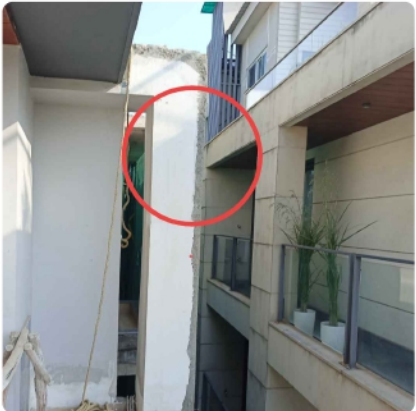
2	Wall work not satisfactory

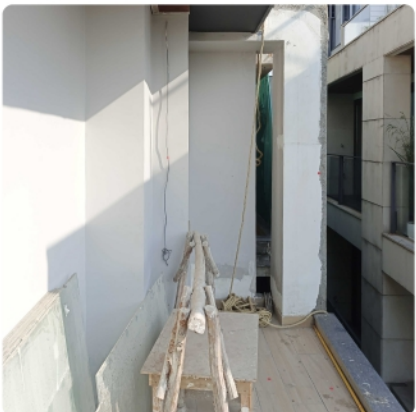
3	Paint work needs to be done through out the flat

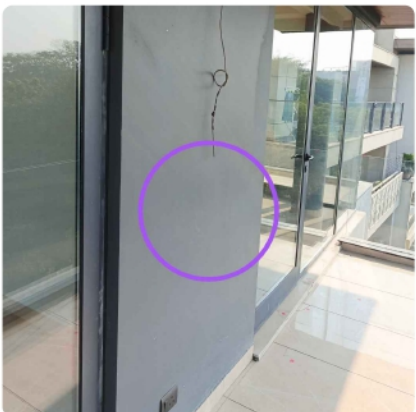
4	Shade of paint not uniform at all places

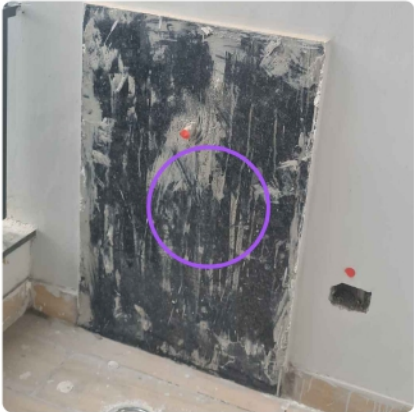
No.	Issue	Picture
1	Stains need to be clean

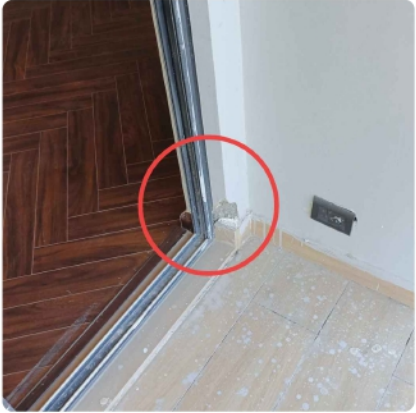
2	Crack/damage observed in wall

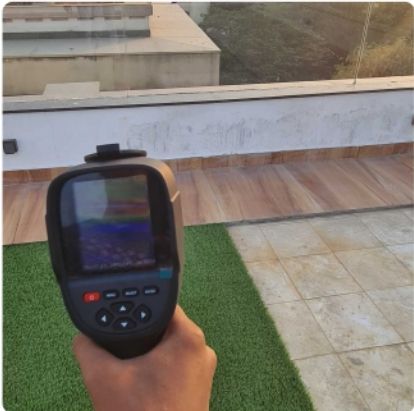
No.	Issue	Picture
1	Dampness observed on wall	 
2	Dampness observed on wall

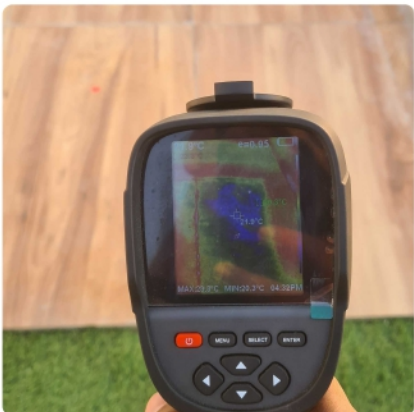
3	Dampness observed on wall

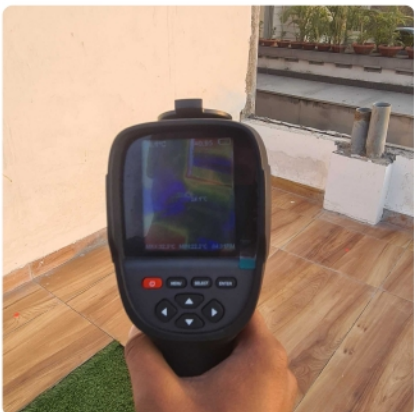
4	Dampness observed on wall

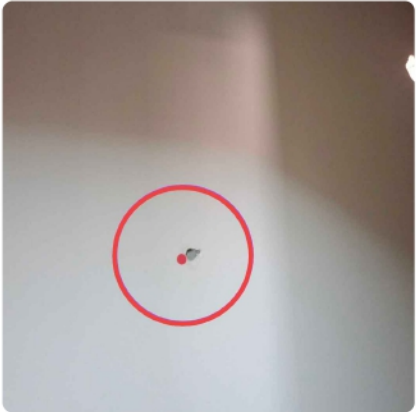
No.	Issue	Picture
1	Damage observed on wall

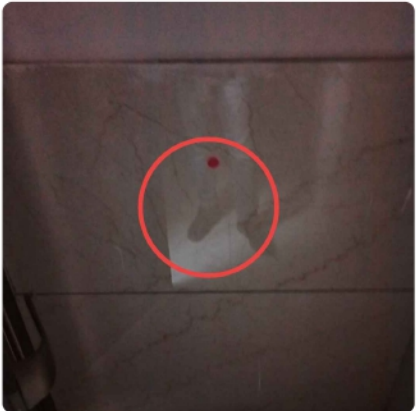
2	Tiles sounding hollow or debonding observed in wall tiles

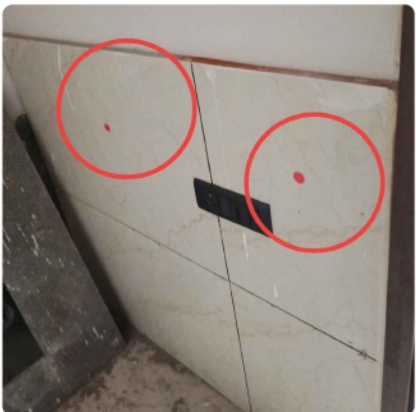
3	Tiles sounding hollow or debonding observed in wall tiles

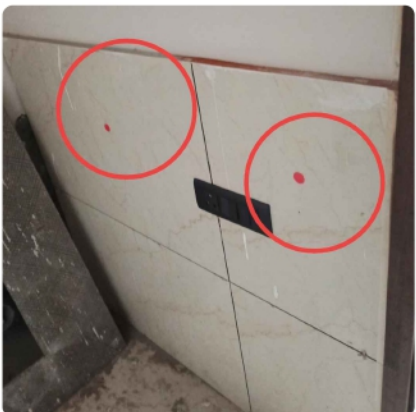
4	Tiles sounding hollow or debonding observed in wall tiles

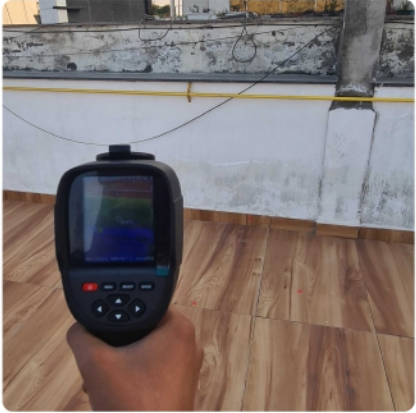
No.	Issue	Picture
1	Dampness observed on wall	 
2	Dampness observed on wall

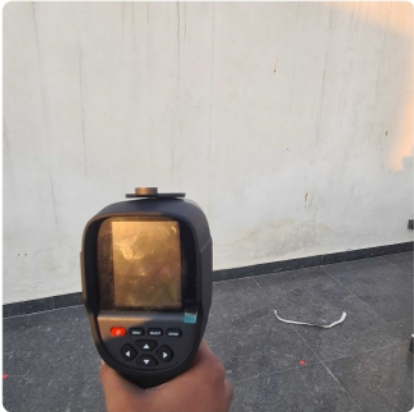
No.	Issue	Picture
5	Dampness observed on wall

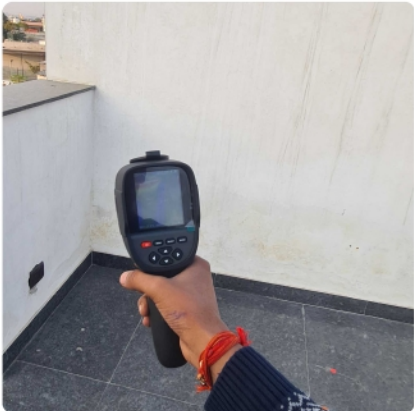
6	Dampness observed on wall

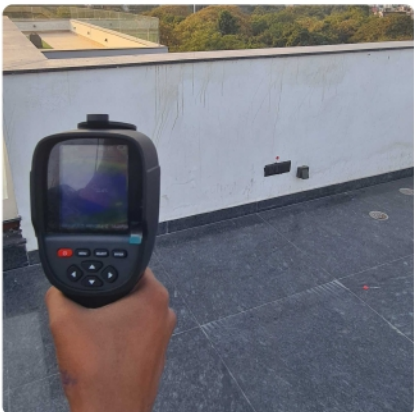
7	Dampness observed on wall

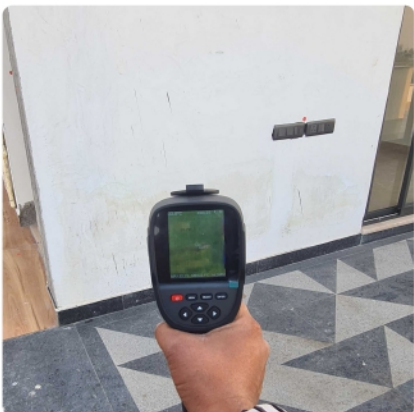
8	Dampness observed on wall

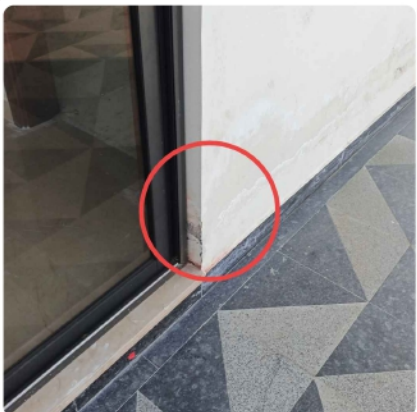
12	Crack/damage observed in wall

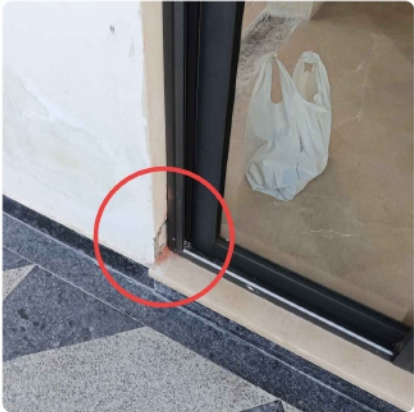
No.	Issue	Picture
13	Crack/damage observed in wall

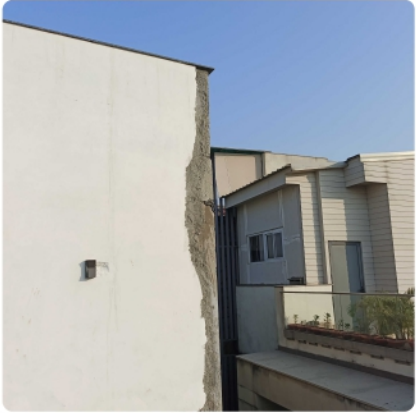
22	Damage observed on wall

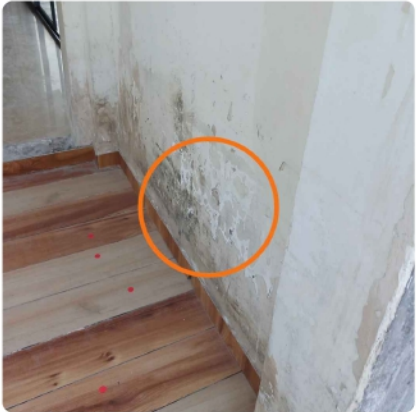
26.17.2. Terrace | Minor

No.	Issue	Picture
1	Air bubble/scratch/peeling off observed in wall

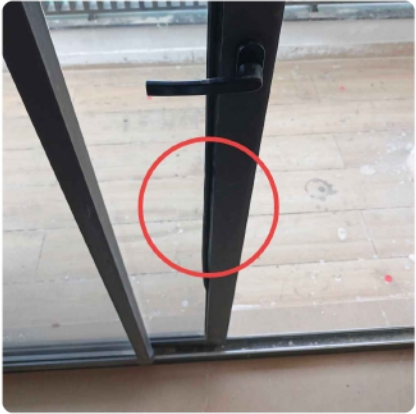
28.1.1. Bedroom 1 | Minor

No.	Issue	Picture
1	Rubber gasket not fixed properly.

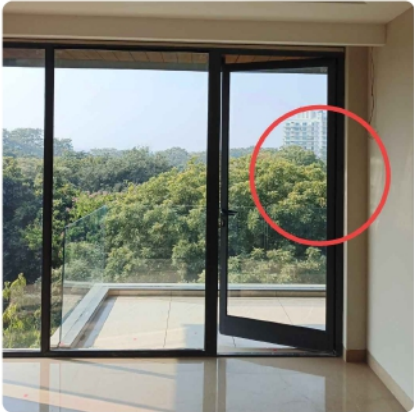
28.3.1. Bedroom 4 | Major

No.	Issue	Picture
1	Gap between frame not sealed with sealant from internal or external side

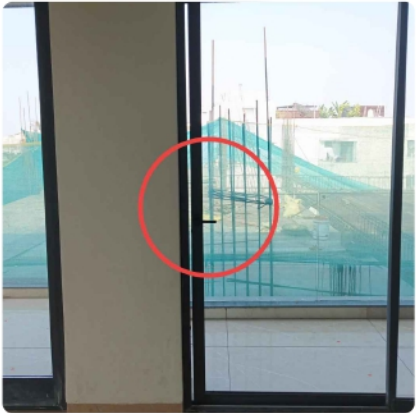
2	Window shutter not closed properly.

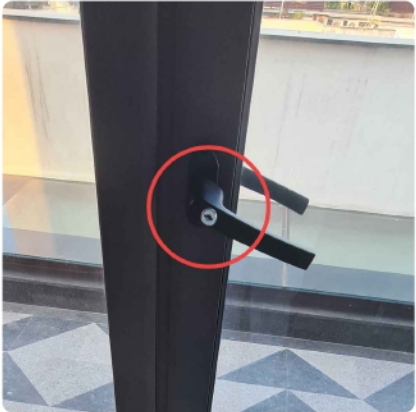
28.8.1. Terrace | Major

No.	Issue	Picture
1	Window shutter lock not working smoothly
